# Access Compliance Report

## Public Rights-of-Way

### (Curb Ramps)

Intersection ID: 12006	Main Street: MEREDITH_AV	Cross Street: WESTERLY_HILLS_DR	Location: SE
ADA ID: 8C8D4CD34787	Ramp Type: Combination1	Initial Pass/Fail: Fail	Overall Compliance: No
Codes/Mitigation Info/Possible Solution		Field Measurements/Component Compliance	
Severity Score: 46.25

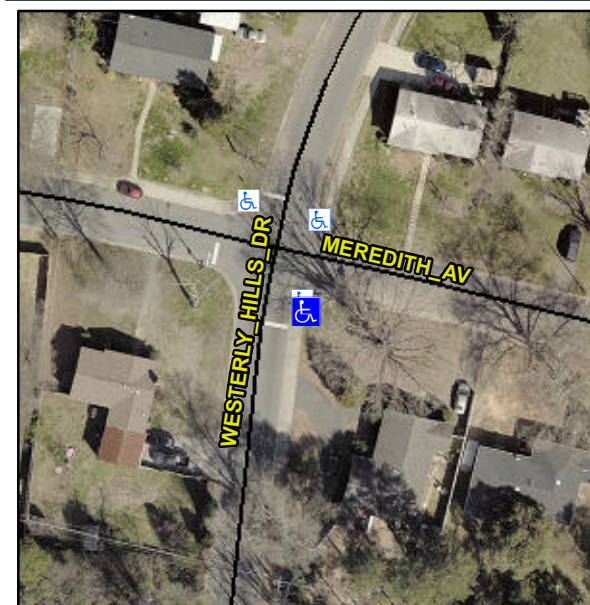
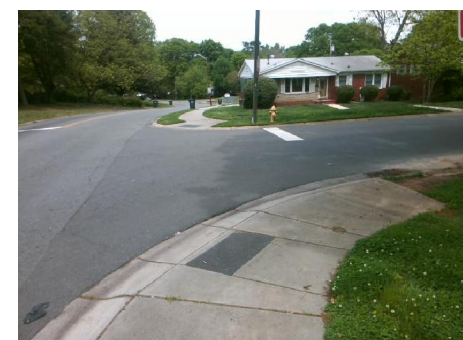
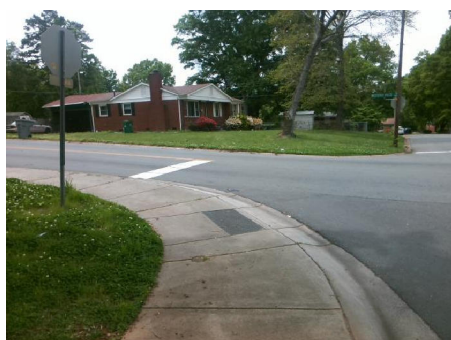
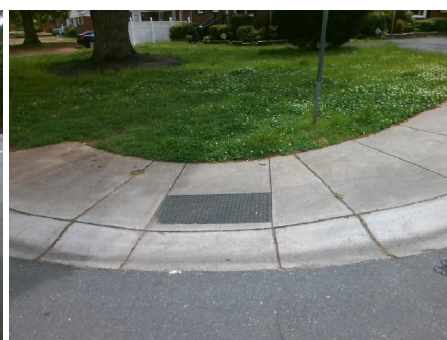
**RP & LT RP < 5%**

**Not Found, R304.5.1, R304.5.3, R304.3.2**

Compliance	Description	Data	Compliance	Description	Data
N/A	Ramp Length LT (in)	40.0	N/A	Ramp Length RT (in)	36.5
Yes	Ramp Width LT (in)	73.0	Yes	Ramp Width RT (in)	70.0
Yes	Ramp Slope LT (%)	2.5	No	Ramp Slope RT (%)	10.3
No	Ramp XSlope LT (%)	3.4	Yes	Ramp XSlope RT (%)	0.4
N/A	Ramp Length (in)	71.0	Yes	Ramp Slope (%)	4.6
No	Ramp Width (in)	46.5	No	Ramp XSlope (%)	7.6
N/A	Flare Type LT	N/A	N/A	Flare Type RT	N/A
N/A	Flare Slope LT (%)	N/A	N/A	Flare Slope RT (%)	N/A
N/A	Flare Traversable LT?	N/A	N/A	Flare Traversable RT?	N/A
N/A	Landing Length (in)	N/A	N/A	DWS Provided?	N/A
N/A	Landing Width (in)	N/A	N/A	DWS Contrast?	N/A
N/A	Landing Slope (%)	N/A	N/A	DWS Length (in)	N/A
N/A	Landing X Slope (%)	N/A	N/A	DWS Full Width?	N/A
N/A	Landing Curb? (Y/N)	N/A	N/A	DWS Offset (in)	N/A
N/A	Shared Landing?	N/A			
N/A	Gutter Ponding?	N/A	N/A	Gutter Slope (%)	N/A
N/A	Gutter Lip Ht (in)	N/A	N/A	Gutter X Slope (%)	N/A
N/A	Painted X Walk1?	No	N/A	Painted X Walk2?	N/A

X Walk 1 Direction	To N		X Walk 2 Direction	N/A
	X Walk 1 Width (in)	N/A		X Walk 2 Width (in)	N/A
	X Walk 1 Slope (%)	3.4		X Walk 2 Slope (%)	N/A
	X Walk 1 X Slope (%)	4.5		X Walk 2 X Slope (%)	N/A
N/A	Ramp inside XWalk1?	N/A	N/A	Ramp inside XWalk2?	N/A
	Road Slope (%)	N/A		Clear Space?	N/A
	Road X Slope (%)	N/A	N/A	Clear Space to XWalk (in)	N/A
			N/A	Any Obstruction?	N/A
				Obstruction Type	N/A
			N/A	Storm Grate/Utility Hazard?	N/A
				Storm Grate/Utility Type	N/A
Yes	Surface Condition? (G/P)	Good			
	Curb Slope (%)	11.6

**Remove & Replace Entire Ramp.**
