Access Compliance Report Public Rights-of-Way (Curb Ramps)

Intersection ID: 2573 Main Street: CAMBELLTON_DR Cross Street: PELORUS_LN Location: SE

ADA ID: 8CCAEF2FAAF2 Ramp Type: PerpDiag Initial Pass/Fail: Fail Overall Compliance: No Severity Score: 37.5

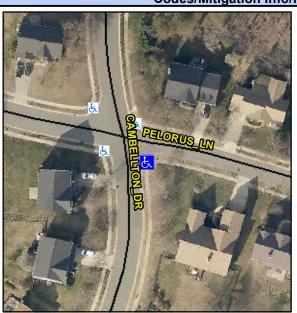
Not Found, R304.2.2, R304.5.3

i ielu ivieasui e	illelits/C	onipo	nent compnance	
Compliance Description		Data	Compliance Description		Data
N/A	Ramp Length (in)	42.0	No	Ramp Slope (%)	8.7
Yes	Ramp Width (in)	48.0	No	Ramp XSlope (%)	7.3
N/A	Flare Type LT	N/A	N/A	Flare Type RT	N/A
N/A	Flare Slope LT (%)	N/A	N/A	Flare Slope RT (%)	N/A
N/A	Flare Traversable LT?	N/A	N/A	Flare Traversable RT?	N/A
N/A	Landing Length (in)	N/A	N/A	DWS Provided?	N/A
N/A	Landing Width (in)	N/A	N/A	DWS Contrast?	N/A
N/A	Landing Slope (%)	N/A	N/A	DWS Length (in)	N/A
N/A	Landing X Slope (%)	N/A	N/A	DWS Full Width?	N/A
N/A	Landing Curb? (Y/N)	N/A	N/A	DWS Offset (in)	N/A
N/A	Shared Landing?	N/A			
N/A	Gutter Ponding?	N/A	N/A	Gutter Slope (%)	N/A
N/A	Gutter Lip Ht (in)	N/A	N/A	Gutter X Slope (%)	N/A
N/A	Painted X Walk1?	No	N/A	Painted X Walk2?	No
	X Walk 1 Direction	To N		X Walk 2 Direction	To W
N/A	X Walk 1 Width (in)	N/A	N/A	X Walk 2 Width (in)	N/A
	X Walk 1 Slope (%)	1.1		X Walk 2 Slope (%)	6.5

X Walk 1 X Slope (%)	6.4		X Walk 2 X Slope (%)	2.1
N/A	Ramp inside XWalk1?	N/A	N/A	Ramp inside XWalk2?	N/A
	Road Slope (%)	6.3	N/A	Clear Space?	N/A
	Road X Slope (%)	3.7	N/A	Clear Space to XWalk (in)	N/A
N/A	Any Obstructions?	N/A	N/A	Storm Grate/Utility Hazard?	N/A
	Obstruction Type			Storm Grate/Utility Type

Remove & Replace Curb Ramp With Two New Directional Ramps or Equivalent.
