## Access Compliance Report Public Rights-of-Way (Curb Ramps)

Intersection ID: 10041619 Main Street: WHITEHALL\_COMMONS\_CENTŒROSDEStreet: N/A Location: SW

ADA ID: 8D50149CF693 Ramp Type: PerpDiag Initial Pass/Fail: Fail Overall Compliance: No Severity Score: 35

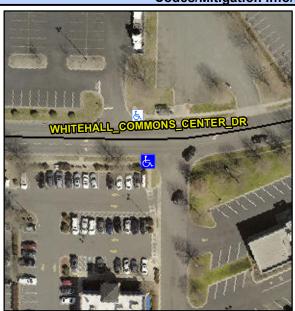
R304.5.1, R304.2.2, R304.5.3

| Field Measurements/Component Compliance | | | | | | |
|---|---|---|---|---|---|---|
| | N/A | Ramp Length (in) | 90.0 | No | Ramp Slope (%) | 12.1 |
| | No | Ramp Width (in) | 40.0 | No | Ramp XSlope (%) | 2.1 |

Remove & Replace Curb Ramp With Two New Directional Ramps or Equivalent.
