Access Compliance Report

Public Rights-of-Way

| Intersection ID: 43753 | Main Street: EARTHENWARE_DR | Cross Street: OLD_POTTERS_RD | Location: SE |
| ADA ID: 8D5F5CE9A39F | Ramp Type: Perp | Initial Pass/Fail: Fail | Overall Compliance: No |

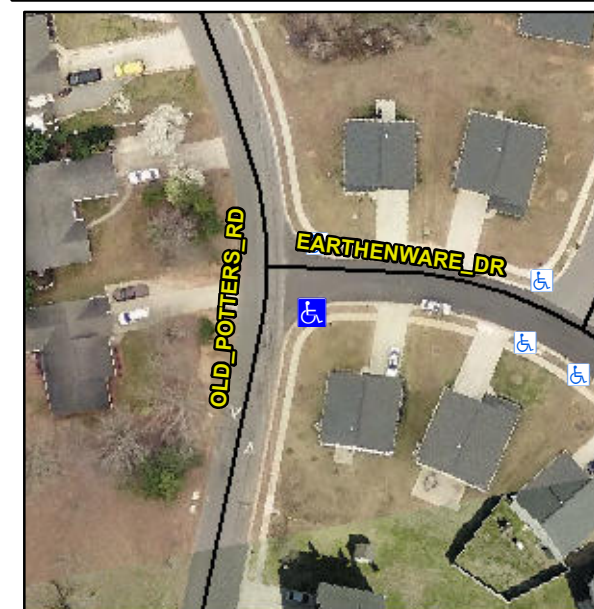
Not Found, R304.5.1, R304.2.2, R304.5.3

| Compliance | Description | Data | Compliance | Description | Data |
|---|---|---|---|---|---|
| N/A | Ramp Length (in) | 47.5 | No | Ramp Slope (%) | 14.6 |
| No | Ramp Width (in) | 46.0 | No | Ramp XSlope (%) | 4.4 |

Remove & Replace Entire Ramp.
