## Access Compliance Report Public Rights-of-Way (Curb Ramps)

Intersection ID: 15763 Main Street: MONROE\_RD Cross Street: N\_WENDOVER\_RD Location: SE

ADA ID: 8D7EEDEE5940 Ramp Type: Perp Initial Pass/Fail: Fail Overall Compliance: No Severity Score: 12.5

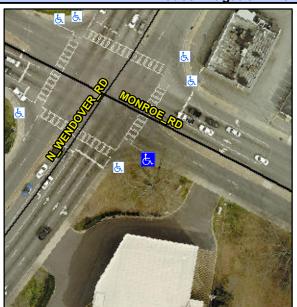
Field Measurements/Component Compliance							
Comp	liance Description	Data	Comp	liance Description	Data		
N/A	Ramp Length (in)	58.0	No	Ramp Slope (%)	10.6		
Yes	Ramp Width (in)	49.0	Yes	Ramp XSlope (%)	0.2		
N/A	Flare Type LT	N/A	N/A	Flare Type RT	N/A		
N/A	Flare Slope LT (%)	N/A	N/A	Flare Slope RT (%)	N/A		
N/A	Flare Traversable LT?	N/A	N/A	Flare Traversable RT?	N/A		
N/A	Landing Length (in)	N/A	N/A	DWS Provided?	N/A		
N/A	Landing Width (in)	N/A	N/A	DWS Contrast?	N/A		
N/A	Landing Slope (%)	N/A	N/A	DWS Length (in)	N/A		
N/A	Landing X Slope (%)	N/A	N/A	DWS Full Width?	N/A		
N/A	Landing Curb? (Y/N)	N/A	N/A	DWS Offset (in)	N/A		
N/A	Shared Landing?	N/A					
N/A	Gutter Ponding?	N/A	N/A	Gutter Slope (%)	N/A		
N/A	Gutter Lip Ht (in)	N/A	N/A	Gutter X Slope (%)	N/A		
N/A	Painted X Walk1?	No	N/A	Painted X Walk2?	N/A		
	X Walk 1 Direction	To NE		X Walk 2 Direction	N/A		
N/A	X Walk 1 Width (in)	N/A	N/A	X Walk 2 Width (in)	N/A

X Walk 1 Slope (%)	0.3		X Walk 2 Slope (%)	N/A		
	X Walk 1 X Slope (%)	0.3		X Walk 2 X Slope (%)	N/A		
N/A	Ramp inside XWalk1?	N/A	N/A	Ramp inside XWalk2?	N/A		
	Road Slope (%)	N/A	N/A	Clear Space?	N/A		
	Road X Slope (%)	N/A	N/A	Clear Space to XWalk (in)	N/A		
N/A	Any Obstructions?	N/A	N/A	Storm Grate/Utility Hazard?	N/A		
	Obstruction Type			Storm Grate/Utility Type			
		N/A			N/A		
			Yes	Surface Condition? (G/P)	Good

POSSIBLE SOLULION		
Possible Solutions:	Co	
Remove & Replace Entire Ramp.		
·	Ye	
	N/A	
Surveyor Notes:	N/A	
N/A	N/A	
	N/A	
	N/A	
	N/A	
PROW/ADA:	N/A	
Not Found, R304.2.2	N/A	
,	N/A	
	N/A	
	N/
