Access Compliance Report

Public Rights-of-Way (Curb Ramps)

| Intersection ID: 5819 | Main Street: HANBERRY_BV | Cross Street: ST_JOSEPH_DR | Location: SE |
| ADA ID: 8DE7D38EB963 | Ramp Type: Perpendicular | Initial Pass/Fail: Fail | Overall Compliance: No |

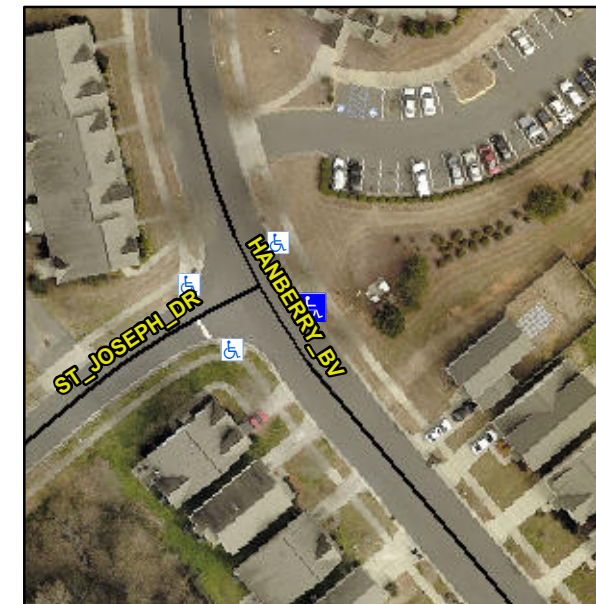
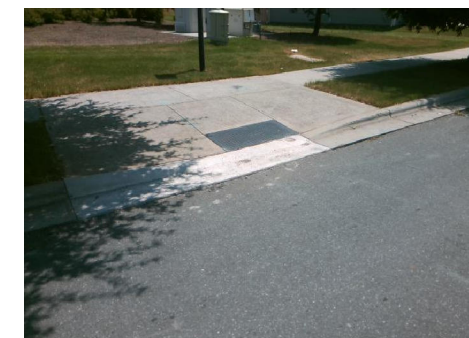
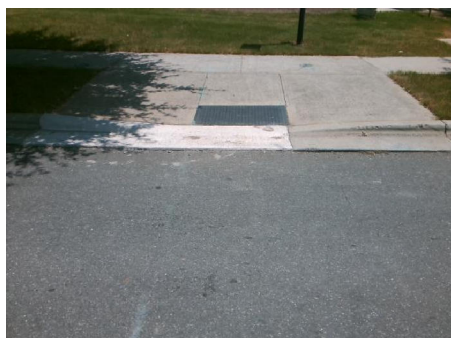
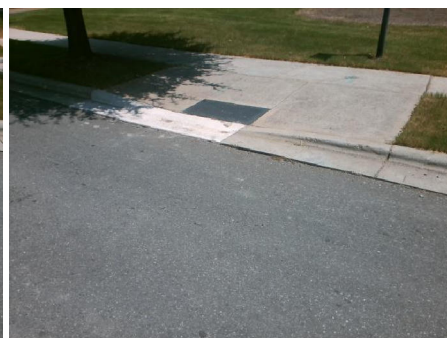
Not Found, R304.2.2

| Compliance | Description | Data | Compliance | Description | Data |
|---|---|---|---|---|---|
| N/A | Ramp Length (in) | 78.0 | No | Ramp Slope (%) | 9.2 |

Remove & Replace Entire Ramp.
