Access Compliance Report Public Rights-of-Way (Curb Ramps)

Intersection ID: 23558Main Street: HAMLIN_PARK_DRCross Street: PARK_RDLocation:NEADA ID: 8E03B05A0FA2Ramp Type: ParaInitial Pass/Fail: FailOverall Compliance: NoSeverity Score: 13.75

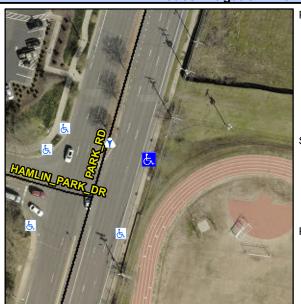
Compliance Description Data Compliance Description Data						
		Data		Description	Data	
N/A	Ramp Length LT (in)	71.0	N/A	Ramp Length RT (in)	72.0	
Yes	Ramp Width LT (in)	59.0	Yes	Ramp Width RT (in)	60.0	
No	Ramp Slope LT (%)	9.0	Yes	Ramp Slope RT (%)	5.3	
No	Ramp XSlope LT (%)	2.4	No	Ramp XSlope RT (%)	2.4	
N/A	Landing Length (in)	N/A	N/A	DWS Provided?	N/A	
N/A	Landing Width (in)	N/A	N/A	DWS Contrast?	N/A	
N/A	Landing Slope (%)	N/A	N/A	DWS Length (in)	N/A	
N/A	Landing X Slope (%)	N/A	N/A	DWS Full Width?	N/A	
N/A	Landing Curb? (Y/N)	N/A	N/A	DWS Offset (in)	N/A	
N/A	Shared Landing?	N/A				
N/A	Gutter Ponding?	N/A	N/A	Gutter Slope (%)	N/A	
N/A	Gutter Lip Ht (in)	N/A	N/A	Gutter X Slope (%)	N/A	
N/A	Painted X Walk1?	No	N/A	Painted X Walk2?	N/A	
	X Walk 1 Direction	To NW		X Walk 2 Direction	N/A	
N/A	X Walk 1 Width (in)	N/A	N/A	X Walk 2 Width (in)	N/A	
	X Walk 1 Slope (%)	5.6		X Walk 2 Slope (%)	N/A	
	X Walk 1 X Slope (%)	0.8		X Walk 2 X Slope (%)	N/A

1 033IDIC OCIULIOII	
Possible Solutions:	C
Remove & Replace Entire Ramp.	N
	Ye
	N
	N
	N/
	N/
Surveyor Notes:	N/
N/A	N/
	N/
	N/
	N/
PROW/ADA:	N/
R304.3.2, R304.5.3	N/
	N/
