# Access Compliance Report

## Public Rights-of-Way

### (Curb Ramps)

| Intersection ID: 17250 | Main Street: CROYDON_RD | Cross Street: QUEENS_RD_WEST | Location: NE |

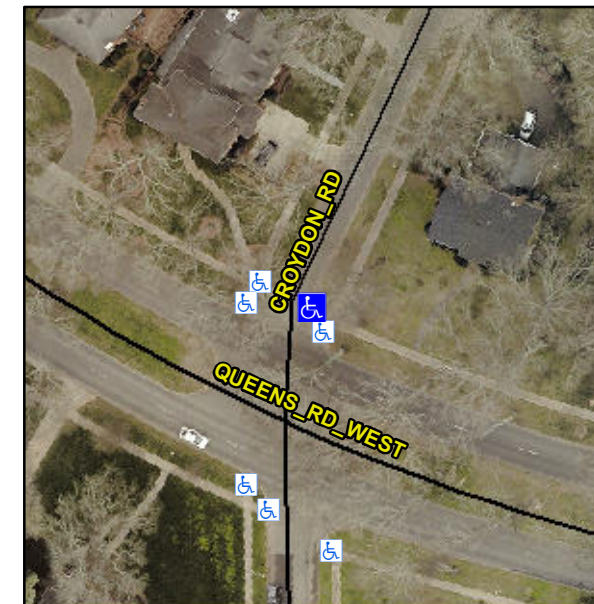
**Not Found, R304.2.2, R304.5.3**

| Compliance | Description | Data | Compliance | Description | Data |
|---|---|---|---|---|---|
| N/A | Ramp Length (in) | 58.0 | No | Ramp Slope (%) | 10.1 |
| Yes | Ramp Width (in) | 62.0 | No | Ramp XSlope (%) | 6.7 |

**Remove & Replace Entire Ramp.**
