## Access Compliance Report Public Rights-of-Way (Curb Ramps)

Intersection ID: 26090Main Street:PROVIDENCE\_RDCross Street:LAKESIDE\_DRLocation:NEADA ID: 8E33A86A4699Ramp Type:PerpendicularInitial Pass/Fail:FailOverall Compliance:NoSeverity Score:46.25

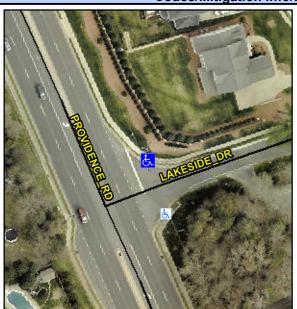
Not Found, R304.5.1, R304.2.2, R304.5.3

Field Measurements/Component Compliance					
Compliance Description		Data	Compliance Description		Data
N/A	Ramp Length (in)	75.0	No	Ramp Slope (%)	9.8
No	Ramp Width (in)	39.0	No	Ramp XSlope (%)	8.4
N/A	Flare Type LT	N/A	N/A	Flare Type RT	N/A
N/A	Flare Slope LT (%)	N/A	N/A	Flare Slope RT (%)	N/A
N/A	Flare Traversable LT?	N/A	N/A	Flare Traversable RT?	N/A
N/A	Landing Length (in)	N/A	N/A	DWS Provided?	N/A
N/A	Landing Width (in)	N/A	N/A	DWS Contrast?	N/A
N/A	Landing Slope (%)	N/A	N/A	DWS Length (in)	N/A
N/A	Landing X Slope (%)	N/A	N/A	DWS Full Width?	N/A
N/A	Landing Curb? (Y/N)	N/A	N/A	DWS Offset (in)	N/A
N/A	Shared Landing?	N/A			
N/A	Gutter Ponding?	N/A	N/A	Gutter Slope (%)	N/A
N/A	Gutter Lip Ht (in)	N/A	N/A	Gutter X Slope (%)	N/A
N/A	Painted X Walk1?	No	N/A	Painted X Walk2?	N/A
	X Walk 1 Direction	To S		X Walk 2 Direction	N/A
N/A	X Walk 1 Width (in)	N/A	N/A	X Walk 2 Width (in)	N/A
	X Walk 1 Slope (%)	6.3		X Walk 2 Slope (%)	N/A

X Walk 1 X Slope (%)	3.9		X Walk 2 X Slope (%)	N/A
N/A	Ramp inside XWalk1?	N/A	N/A	Ramp inside XWalk2?	N/A
	Road Slope (%)	N/A	N/A	Clear Space?	N/A
	Road X Slope (%)	N/A	N/A	Clear Space to XWalk (in)	N/A
N/A	Any Obstructions?	N/A	N/A	Storm Grate/Utility Hazard?	N/A
	Obstruction Type			Storm Grate/Utility Type	
		N/A			N/A
			Yes	Surface Condition? (G/P)	Good
90	A WOOD SHIP OF THE SHIP	•	-

Remove & Replace Entire Ramp.
