Access Compliance Report

Public Rights-of-Way

(Curb Ramps)

Intersection ID: 30431	Main Street: CEDAR_ROCK_DR	Cross Street: ELM_BEND_DR	Location: SE
ADA ID: 8E61623B5DB4	Ramp Type: PerpDiag	Initial Pass/Fail: Fail	Overall Compliance: No
Severity Score: 8.75			
Codes/Mitigation Info/Possible Solution		Field Measurements/Component Compliance

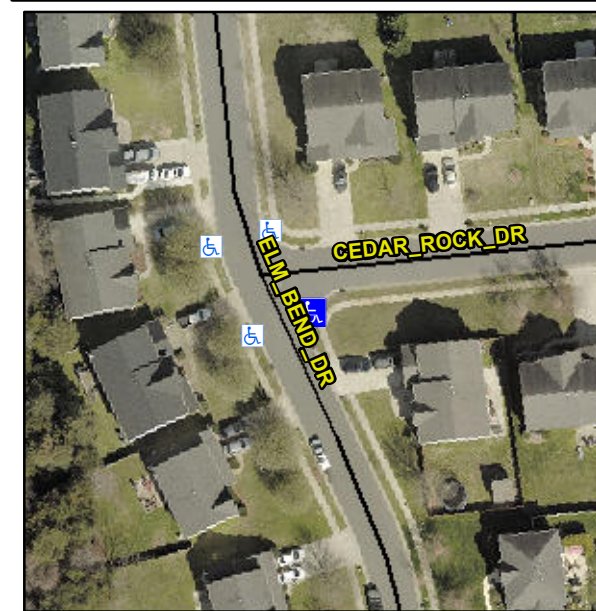
Not Found, R304.5.1

Compliance	Description	Data	Compliance	Description	Data
N/A	Ramp Length (in)	48.0	Yes	Ramp Slope (%)	5.9
No	Ramp Width (in)	43.0	Yes	Ramp XSlope (%)	0.6
N/A	Flare Type LT	N/A	N/A	Flare Type RT	N/A
N/A	Flare Slope LT (%)	N/A	N/A	Flare Slope RT (%)	N/A
N/A	Flare Traversable LT?	N/A	N/A	Flare Traversable RT?	N/A
N/A	Landing Length (in)	N/A	N/A	DWS Provided?	N/A
N/A	Landing Width (in)	N/A	N/A	DWS Contrast?	N/A
N/A	Landing Slope (%)	N/A	N/A	DWS Length (in)	N/A
N/A	Landing X Slope (%)	N/A	N/A	DWS Full Width?	N/A
N/A	Landing Curb? (Y/N)	N/A	N/A	DWS Offset (in)	N/A
N/A	Shared Landing?	N/A			
N/A	Gutter Ponding?	N/A	N/A	Gutter Slope (%)	N/A
N/A	Gutter Lip Ht (in)	N/A	N/A	Gutter X Slope (%)	N/A
N/A	Painted X Walk1?	No	N/A	Painted X Walk2?	No
	X Walk 1 Direction	To NW		X Walk 2 Direction	To SW
N/A	X Walk 1 Width (in)	N/A	N/A	X Walk 2 Width (in)	N/A
	X Walk 1 Slope (%)	1.3		X Walk 2 Slope (%)	1.2
	X Walk 1 X Slope (%)	0.4		X Walk 2 X Slope (%)	0.2

N/A	Ramp inside XWalk1?	N/A	N/A	Ramp inside XWalk2?	N/A
	Road Slope (%)	1.0	N/A	Clear Space?	N/A
	Road X Slope (%)	1.7	N/A	Clear Space to XWalk (in)	N/A
N/A	Any Obstructions?	N/A	N/A	Storm Grate/Utility Hazard?	N/A
	Obstruction Type			Storm Grate/Utility Type	
		N/A			N/A
			Yes	Surface Condition? (G/P)	Good

Remove & Replace Curb Ramp With Two New Directional Ramps or Equivalent.
