Access Compliance Report Public Rights-of-Way (Curb Ramps)

Intersection ID: 3246 Main Street: OLD_TIMBER_RD Cross Street: SADDLE_PACE_LN Location: ADA ID: 8E7F74490C46 Ramp Type: Perpendicular Initial Pass/Fail: Fail **Overall Compliance: No** Severity Score: 21.25

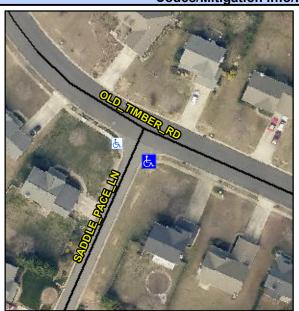
SADDLE PACE LN Street 1 Name Stop Condition-Street 2 StopSign Street 2 Name N/A Stop Condition-Street 1 N/A Possible Solutions: Remove & Replace Entire Ramp. Surveyor Notes: N/A PROW/ADA: Not Found, R304.5.1, R304.5.3

| Field Measurements/Component Compliance | | | | | |
|---|---|---|---|---|---|
| N/A | Ramp Length (in) | 49.0 | Yes | Ramp Slope (%) | 6.1 |
| No | Ramp Width (in) | 38.0 | No | Ramp XSlope (%) | 5.7 |
