Access Compliance Report

Public Rights-of-Way

(Curb Ramps)

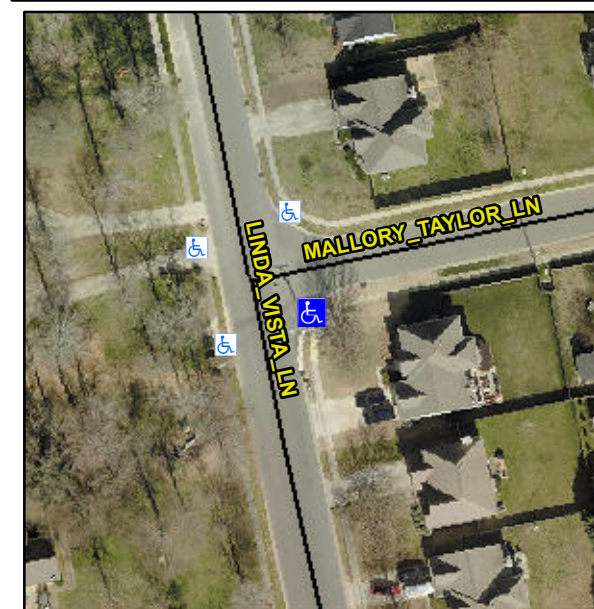
Intersection ID: 44306	Main Street: MALLORY_TAYLOR_LN	Cross Street: LINDA_VISTA_LN	Location: SE
ADA ID: 8EA455C33CB7	Ramp Type: Perpendicular Diagonal	Initial Pass/Fail: Fail	Overall Compliance: No
		Severity Score: 8.75	
Codes/Mitigation Info/Possible Solution		Field Measurements/Component Compliance

Not Found, R304.5.1

Compliance	Description	Data	Compliance	Description	Data
N/A	Ramp Length (in)	49.0	Yes	Ramp Slope (%)	5.4
No	Ramp Width (in)	40.0	Yes	Ramp XSlope (%)	1.3
N/A	Flare Type LT	N/A	N/A	Flare Type RT	N/A
N/A	Flare Slope LT (%)	N/A	N/A	Flare Slope RT (%)	N/A
N/A	Flare Traversable LT?	N/A	N/A	Flare Traversable RT?	N/A
N/A	Landing Length (in)	N/A	N/A	DWS Provided?	N/A
N/A	Landing Width (in)	N/A	N/A	DWS Contrast?	N/A
N/A	Landing Slope (%)	N/A	N/A	DWS Length (in)	N/A
N/A	Landing X Slope (%)	N/A	N/A	DWS Full Width?	N/A
N/A	Landing Curb? (Y/N)	N/A	N/A	DWS Offset (in)	N/A
N/A	Shared Landing?	N/A			
N/A	Gutter Ponding?	N/A	N/A	Gutter Slope (%)	N/A
N/A	Gutter Lip Ht (in)	N/A	N/A	Gutter X Slope (%)	N/A
N/A	Painted X Walk1?	No	N/A	Painted X Walk2?	No
	X Walk 1 Direction	To N		X Walk 2 Direction	To W
N/A	X Walk 1 Width (in)	N/A	N/A	X Walk 2 Width (in)	N/A
	X Walk 1 Slope (%)	0.0		X Walk 2 Slope (%)	1.7
	X Walk 1 X Slope (%)	4.0		X Walk 2 X Slope (%)	3.3

N/A	Ramp inside XWalk1?	N/A	N/A	Ramp inside XWalk2?	N/A
	Road Slope (%)	0.3	N/A	Clear Space?	N/A
	Road X Slope (%)	4.6	N/A	Clear Space to XWalk (in)	N/A
N/A	Any Obstructions?	N/A	N/A	Storm Grate/Utility Hazard?	N/A
	Obstruction Type			Storm Grate/Utility Type	
		N/A			N/A
		Yes		Surface Condition? (G/P)	Good

Remove & Replace Curb Ramp With Two New Directional Ramps or Equivalent.
