## Access Compliance Report Public Rights-of-Way (Curb Ramps)

Intersection ID: 10642 Main Street: HOBBS\_ST Cross Street: SYLVANIA\_AV Location: N

ADA ID: 8EE3712EEA1E Ramp Type: Perpendicular Initial Pass/Fail: Fail Overall Compliance: No Severity Score: 1.25

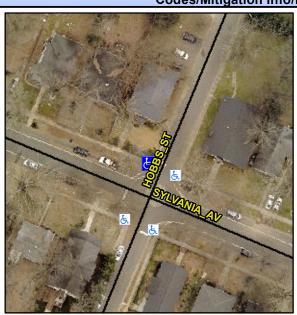
Not Found, R304.5.3

| Field Measurements/Component Compliance | | | | | |
|---|--|---|---|---|---|
| Yes | Ramp Width (in) | 48.0 | No | Ramp XSlope (%) | 2.7 |

Remove & Replace Entire Ramp.
