Access Compliance Report

Public Rights-of-Way

(Curb Ramps)

Intersection ID: 10040213	Main Street: TYVOLA_RD	Cross Street: N/A	Location: NW
ADA ID: 8EEBA86D8BE4	Ramp Type: Combination1Diag	Initial Pass/Fail: Fail	Overall Compliance: No
		Severity Score: 0

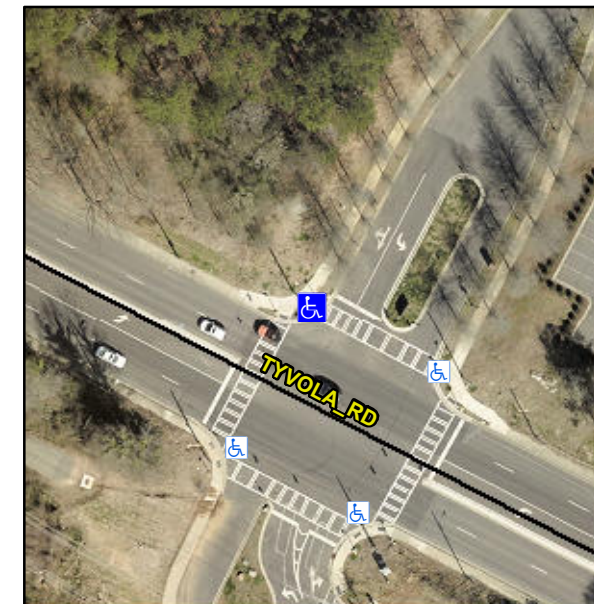
Not Found, R304.5.1, R304.3.2, R304.5.3

Compliance	Description	Data	Compliance	Description	Data
N/A	Ramp Length LT (in)	54.0	N/A	Ramp Length RT (in)	54.0
No	Ramp Width LT (in)	36.0	No	Ramp Width RT (in)	37.0
No	Ramp Slope LT (%)	9.5	Yes	Ramp Slope RT (%)	5.9
No	Ramp XSlope LT (%)	3.0	No	Ramp XSlope RT (%)	3.0
N/A	Ramp Length (in)	25.0	Yes	Ramp Slope (%)	6.6
Yes	Ramp Width (in)	48.0	Yes	Ramp XSlope (%)	1.0
N/A	Flare Type LT	N/A	N/A	Flare Type RT	N/A
N/A	Flare Slope LT (%)	N/A	N/A	Flare Slope RT (%)	N/A
N/A	Flare Traversable LT?	N/A	N/A	Flare Traversable RT?	N/A
N/A	Landing Length (in)	N/A	N/A	DWS Provided?	N/A
N/A	Landing Width (in)	N/A	N/A	DWS Contrast?	N/A
N/A	Landing Slope (%)	N/A	N/A	DWS Length (in)	N/A
N/A	Landing X Slope (%)	N/A	N/A	DWS Full Width?	N/A
N/A	Landing Curb? (Y/N)	N/A	N/A	DWS Offset (in)	N/A
N/A	Shared Landing?	N/A			
N/A	Gutter Ponding?	N/A	N/A	Gutter Slope (%)	N/A
N/A	Gutter Lip Ht (in)	N/A	N/A	Gutter X Slope (%)	N/A
N/A	Painted X Walk1?	No	N/A	Painted X Walk2?	No

X Walk 1 Direction	To S		X Walk 2 Direction	To E
	X Walk 1 Width (in)	N/A		X Walk 2 Width (in)	N/A
	X Walk 1 Slope (%)	2.4		X Walk 2 Slope (%)	1.0
	X Walk 1 X Slope (%)	2.7		X Walk 2 X Slope (%)	0.1
N/A	Ramp inside XWalk1?	N/A	N/A	Ramp inside XWalk2?	N/A
	Road Slope (%)	1.7		Clear Space?	N/A
	Road X Slope (%)	1.3	N/A	Clear Space to XWalk (in)	N/A
			N/A	Any Obstruction?	N/A
				Obstruction Type	N/A
			N/A	Storm Grate/Utility Hazard?	N/A
				Storm Grate/Utility Type	N/A
			Yes	Surface Condition? (G/P)	Good
				Curb Slope (%)	31.5

Remove & Replace Curb Ramp With Two New Directional Ramps or Equivalent.

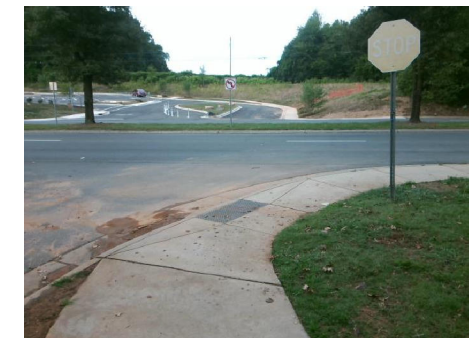
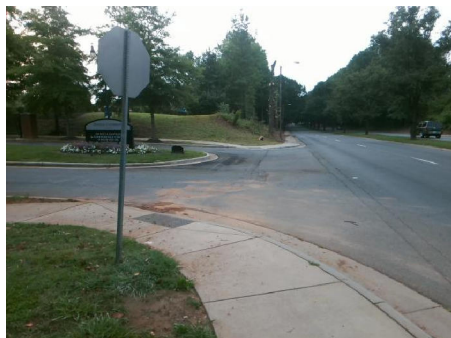
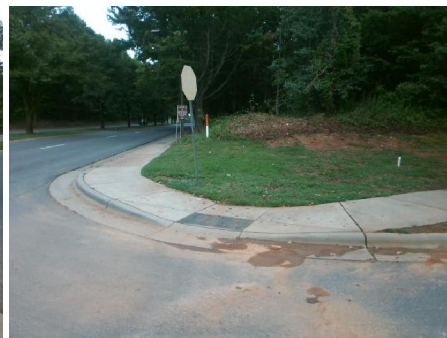
MEDIAN ACROSS TYVOLA RD
