Intersection ID: 10041968	Main Street: WINDSOR_CASTLE_LN	Cross Street: N/A	Location:	W
ADA ID: 8F4D87FC8BE0	Ramp Type: Perpendicular Diagonal	Initial Pass/Fail: Fail	Overall Compliance: No	Severity Score: 18.75

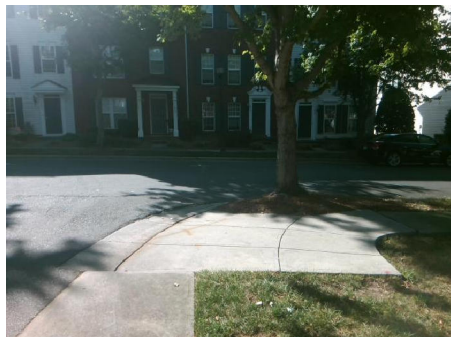
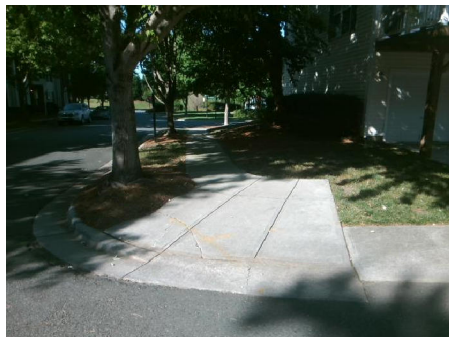
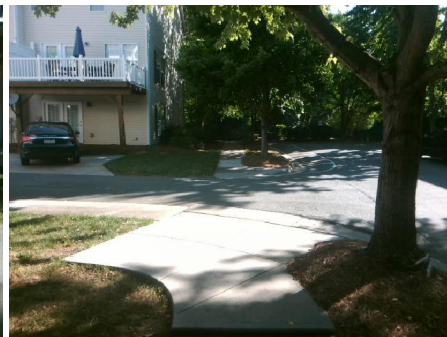
Compliance	Description	Data	Compliance	Description	Data
N/A	Ramp Length (in)	76.0	Yes	Ramp Slope (%)	7.2
No	Ramp Width (in)	32.0	Yes	Ramp XSlope (%)	2.5
N/A	Flare Type LT	N/A	N/A	Flare Type RT	N/A
N/A	Flare Slope LT (%)	N/A	N/A	Flare Slope RT (%)	N/A
N/A	Flare Traversable LT?	N/A	N/A	Flare Traversable RT?	N/A
N/A	Landing Length (in)	N/A	N/A	DWS Provided?	N/A
N/A	Landing Width (in)	N/A	N/A	DWS Contrast?	N/A
N/A	Landing Slope (%)	N/A	N/A	DWS Length (in)	N/A
N/A	Landing X Slope (%)	N/A	N/A	DWS Full Width?	N/A
N/A	Landing Curb? (Y/N)	N/A	N/A	DWS Offset (in)	N/A
N/A	Shared Landing?	N/A			
N/A	Gutter Ponding?	N/A	N/A	Gutter Slope (%)	N/A
N/A	Gutter Lip Ht (in)	N/A	N/A	Gutter X Slope (%)	N/A
N/A	Painted X Walk1?	No	N/A	Painted X Walk2?	No
	X Walk 1 Direction	To SE		X Walk 2 Direction	To NE
N/A	X Walk 1 Width (in)	N/A	N/A	X Walk 2 Width (in)	N/A
	X Walk 1 Slope (%)	1.4		X Walk 2 Slope (%)	1.3
	X Walk 1 X Slope (%)	3.9		X Walk 2 X Slope (%)	1.0

N/A	Ramp inside XWalk1?	N/A	N/A	Ramp inside XWalk2?	N/A
	Road Slope (%)	3.1	N/A	Clear Space?	N/A
	Road X Slope (%)	2.6	N/A	Clear Space to XWalk (in)	N/A
N/A	Any Obstructions?	N/A	N/A	Storm Grate/Utility Hazard?	N/A
	Obstruction Type			Storm Grate/Utility Type	
		N/A			N/A
			Yes	Surface Condition? (G/P)	Good

**Remove & Replace Curb Ramp With Two New Directional Ramps or Equivalent.**
