Access Compliance Report

Public Rights-of-Way

(Curb Ramps)

Intersection ID: 10242	Main Street: KING_RD	Cross Street: LINDA_LAKE_DR	Location: SW
ADA ID: 8F6945256A41	Ramp Type: Combination1	Initial Pass/Fail: Fail	Overall Compliance: No
		Severity Score: 10

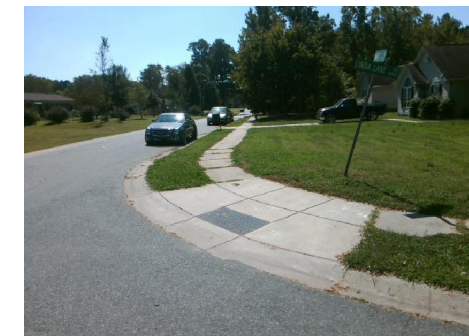
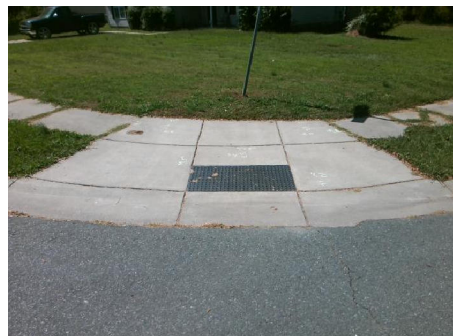
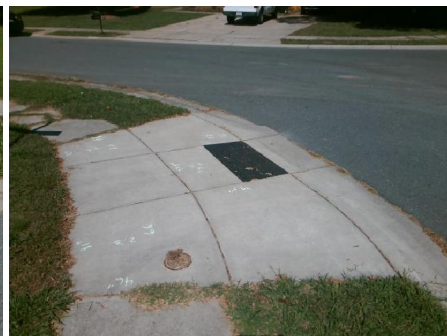
RT RP < 5%

Not Found, R304.5.1, R304.5.1, R304.5.3

Remove & Replace Entire Ramp.
