# Access Compliance Report

## Public Rights-of-Way (Curb Ramps)

Intersection ID: 2890	Main Street: BROKEN_PINE_LN	Cross Street: EVERGREEN_HOLLOW_DR	Location: SW
ADA ID: 900ABC9348CE	Ramp Type: BlendTrans2	Initial Pass/Fail: Fail	Overall Compliance: No
Severity Score: 15			
Codes/Mitigation Info/Possible Solution		Field Measurements/Component Compliance

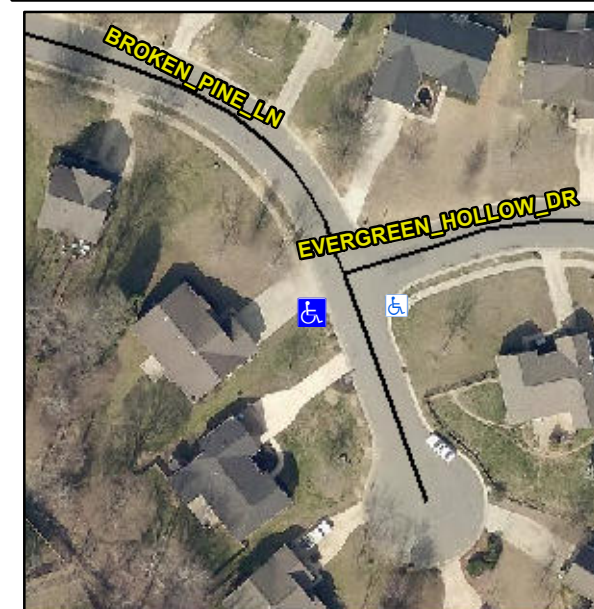
**Not Found, R302.7**

N/A	Ramp inside XWalk1?	N/A	N/A	Ramp inside XWalk2?	N/A
	Road Slope (%)	3.6		Clear Space?	N/A
	Road X Slope (%)	5.4	N/A	Clear Space to XWalk (in)	N/A
N/A	Any Obstructions?	N/A	N/A	Storm Grate/Utility Hazard?	N/A
	Obstruction Type			Storm Grate/Utility Type	
		N/A			N/A
		No		Surface Condition? (G/P)	Poor
		No		Curb Slope (%)	5.7

**Remove & Replace Curb Ramp With Two New Directional Ramps or Equivalent.**

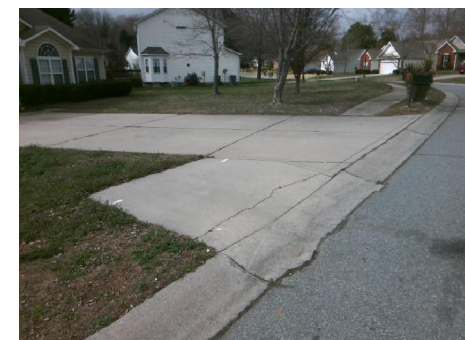
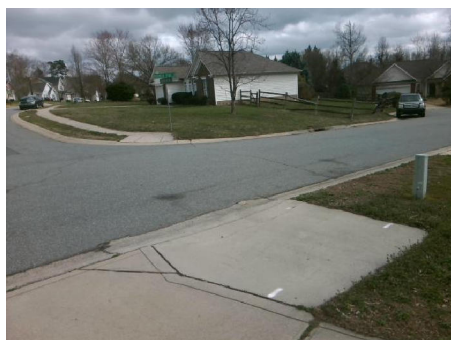
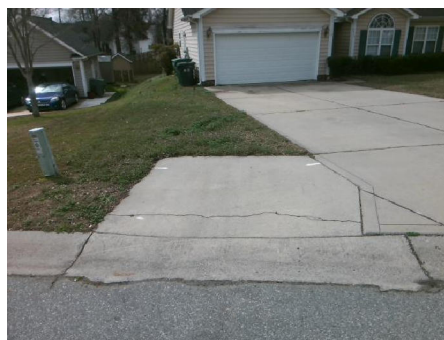
Compliance	Description	Data	Compliance	Description	Data
N/A	Ramp Length (in)	95.0	Yes	BlendTrans Slope (%)	3.3
Yes	Ramp Width (in)	99.0	Yes	BlendTrans XSlope (%)	0.0
N/A	Flare Type LT	N/A	N/A	Flare Type RT	N/A
N/A	Flare Slope LT (%)	N/A	N/A	Flare Slope RT (%)	N/A
N/A	Flare Traversable LT?	N/A	N/A	Flare Traversable RT?	N/A
N/A	Landing Length (in)	N/A	N/A	DWS Provided?	N/A
N/A	Landing Width (in)	N/A	N/A	DWS Contrast?	N/A
N/A	Landing Slope (%)	N/A	N/A	DWS Length (in)	N/A
N/A	Landing X Slope (%)	N/A	N/A	DWS Full Width?	N/A
N/A	Landing Curb? (Y/N)	N/A	N/A	DWS Offset (in)	N/A
N/A	Shared Landing?	N/A			
N/A	Gutter Ponding?	N/A	N/A	Gutter Slope (%)	N/A
N/A	Gutter Lip Ht (in)	N/A	N/A	Gutter X Slope (%)	N/A
N/A	Painted X Walk1?	No	N/A	Painted X Walk2?	N/A
	X Walk 1 Direction	To E		X Walk 2 Direction	N/A
	X Walk 1 Width (in)	N/A		X Walk 2 Width (in)	N/A
	X Walk 1 Slope (%)	5.4		X Walk 2 Slope (%)	N/A
	X Walk 1 X Slope (%)	3.6		X Walk 2 X Slope (%)	N/A
