Access Compliance Report

Public Rights-of-Way

| Intersection ID: 9561 | Main Street: SELDON_DR | Cross Street: N/A | Location: S |
| ADA ID: 90707D28B636 | Ramp Type: BlendTrans1 | Initial Pass/Fail: Fail | Overall Compliance: No |

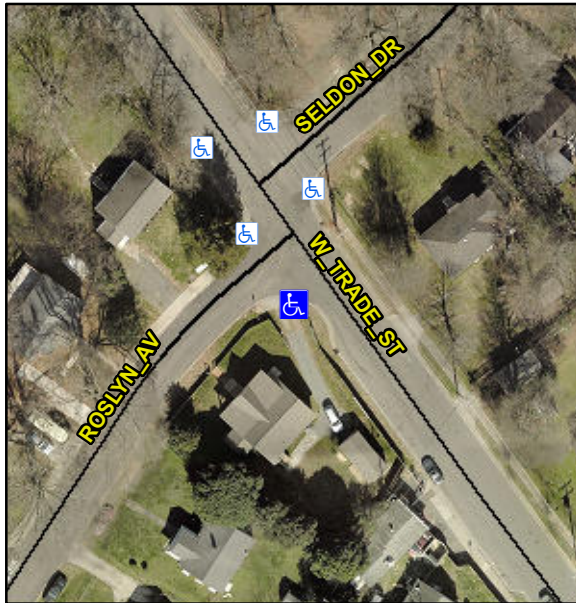
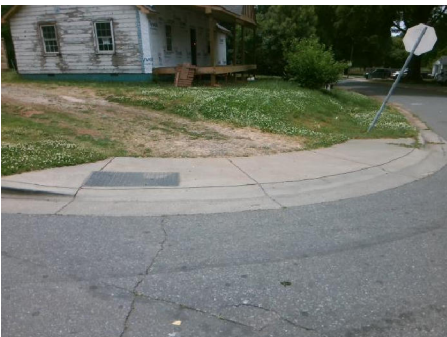
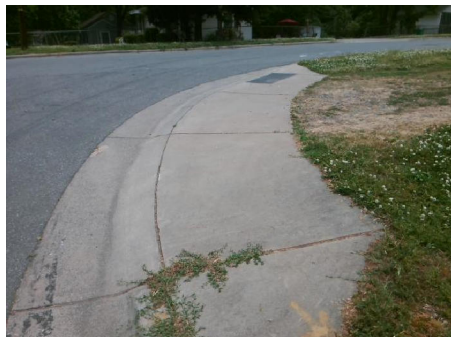
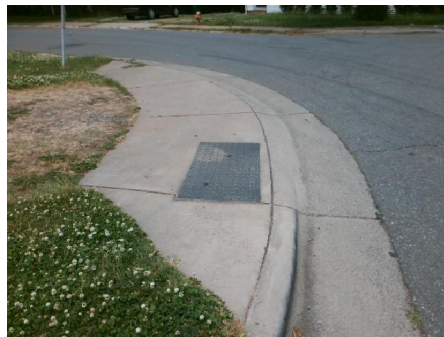
NO LT SW

Not Found, R304.5.3

| Compliance | Description | Data | Compliance | Description | Data |
|---|---|---|---|---|---|
| Yes | Ramp Width (in) | 75.0 | No | BlendTrans XSlope (%) | 6.4 |
| | | | No | Curb Slope (%) | 13.4 |

Remove & Replace Curb Ramp With Two New Directional Ramps or Equivalent.
