## Access Compliance Report Public Rights-of-Way (Curb Ramps)

Intersection ID: 6463Main Street:ROSY\_MOUND\_LNCross Street:SLATER\_SPRINGS\_DRLocation:NWADA ID: 9122501EC92ARamp Type:PerpInitial Pass/Fail:FailOverall Compliance:NoSeverity Score:12.5

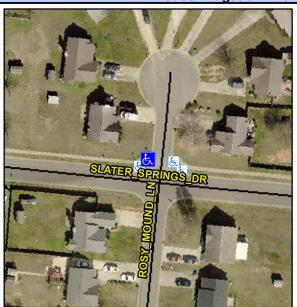
| Compliance Description Da | | Data | Compliance Description | | Data |
|---|---|---|---|---|---|
| N/A | Ramp Length (in) | 90.0 | No | Ramp Slope (%) | 9.0 |

Total Cost: \$ 1850.00
