Access Compliance Report

Public Rights-of-Way

(Curb Ramps)

Intersection ID: 46816	Main Street: CYPRESS_VIEW_DR	Cross Street: ARBOR_VISTA_DR	Location: SW
ADA ID: 91448AF3B22E	Ramp Type: Perp	Initial Pass/Fail: Fail	Overall Compliance: No
Severity Score: 21.25			
Codes/Mitigation Info/Possible Solution		Field Measurements/Component Compliance

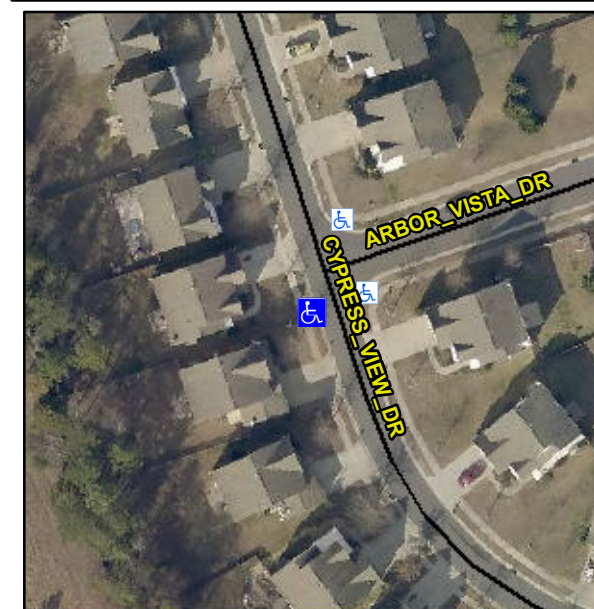
Not Found, R304.5.1, R304.2.2

Compliance	Description	Data	Compliance	Description	Data
N/A	Ramp Length (in)	47.0	No	Ramp Slope (%)	8.6
No	Ramp Width (in)	46.5	Yes	Ramp XSlope (%)	2.0
N/A	Flare Type LT	N/A	N/A	Flare Type RT	N/A
N/A	Flare Slope LT (%)	N/A	N/A	Flare Slope RT (%)	N/A
N/A	Flare Traversable LT?	N/A	N/A	Flare Traversable RT?	N/A
N/A	Landing Length (in)	N/A	N/A	DWS Provided?	N/A
N/A	Landing Width (in)	N/A	N/A	DWS Contrast?	N/A
N/A	Landing Slope (%)	N/A	N/A	DWS Length (in)	N/A
N/A	Landing X Slope (%)	N/A	N/A	DWS Full Width?	N/A
N/A	Landing Curb? (Y/N)	N/A	N/A	DWS Offset (in)	N/A
N/A	Shared Landing?	N/A			
N/A	Gutter Ponding?	N/A	N/A	Gutter Slope (%)	N/A
N/A	Gutter Lip Ht (in)	N/A	N/A	Gutter X Slope (%)	N/A
N/A	Painted X Walk1?	No	N/A	Painted X Walk2?	N/A
	X Walk 1 Direction	To E		X Walk 2 Direction	N/A
N/A	X Walk 1 Width (in)	N/A	N/A	X Walk 2 Width (in)	N/A
	X Walk 1 Slope (%)	2.6		X Walk 2 Slope (%)	N/A
	X Walk 1 X Slope (%)	2.7		X Walk 2 X Slope (%)	N/A

Remove & Replace Entire Ramp.

Total Cost: \$ 1850.00
