Access Compliance Report

Public Rights-of-Way

| Intersection ID: 48429 | Main Street: ROUSAY_RD | Cross Street: SEAMILL_RD | Location: SE |
| ADA ID: 914866DA3376 | Ramp Type: PerpDiag | Initial Pass/Fail: Fail | Overall Compliance: No |

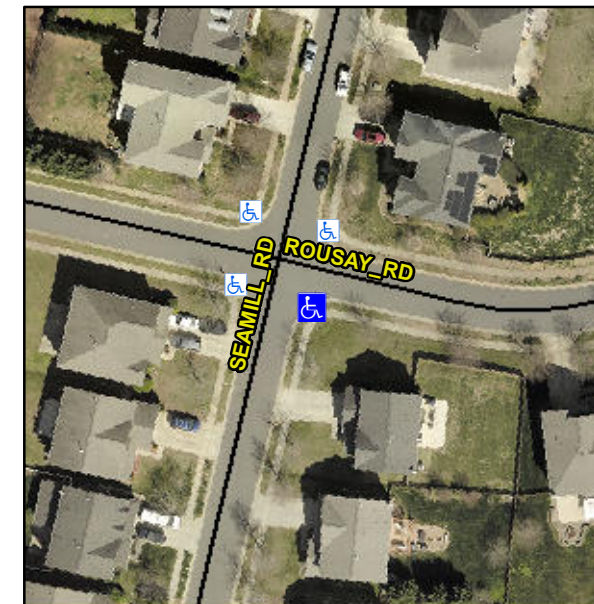
Not Found, R304.5.1, R304.2.2

| Compliance | Description | Data | Compliance | Description | Data |
|---|---|---|---|---|---|
| N/A | Ramp Length (in) | 47.5 | No | Ramp Slope (%) | 9.0 |
| No | Ramp Width (in) | 47.0 | Yes | Ramp XSlope (%) | 0.1 |

Remove & Replace Curb Ramp With Two New Directional Ramps or Equivalent.
