# Access Compliance Report

## Public Rights-of-Way

### (Curb Ramps)

| Intersection ID: 45172 | Main Street: ELDON_DR | Cross Street: LINDEN_TREE_LN | Location: SE |

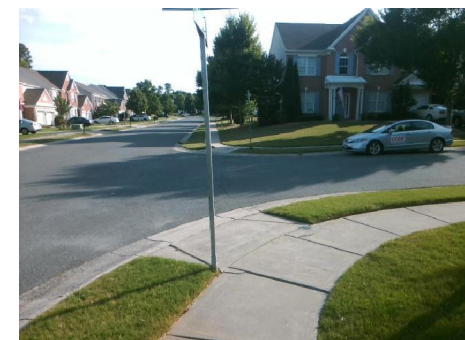
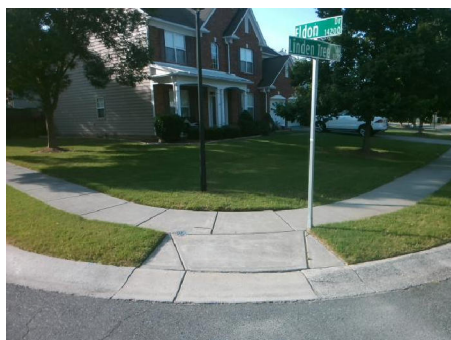
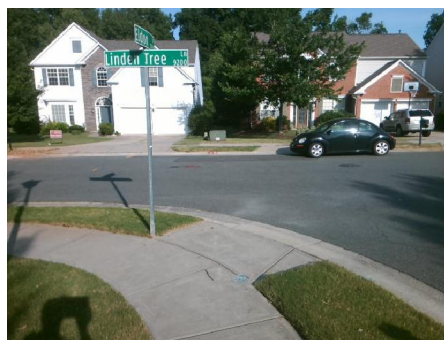
**Not Found, R304.5.3, R305, R304.5.4**

| Compliance | Description | Data | Compliance | Description | Data |
|---|---|---|---|---|---|
| Yes | Ramp Width (in) | 53.0 | No | BlendTrans XSlope (%) | 4.4 |
| Yes | Landing Length (in) | 48.0 | No | DWS Provided? | No |
| No | Landing X Slope (%) | 3.6 | N/A | DWS Full Width? | No |
| Yes | Gutter Ponding? | No | No | Gutter Slope (%) | 5.6 |
| Yes | Gutter Lip Ht (in) | 0.0 | No | Gutter X Slope (%) | 3.3 |
| | | | No | Curb Slope (%) | 18.6 |

**Remove & Replace Curb Ramp With Two New Directional Ramps or Equivalent. Remove & Replace Gutter.**
