Access Compliance Report

Public Rights-of-Way

(Curb Ramps)

Intersection ID: 45882	Main Street: HOMESTEAD_GLEN_BV	Cross Street: VALLEYDALE_RD	Location:	W
ADA ID: 92E623C7EE0E	Ramp Type: Combination1	Initial Pass/Fail: Fail	Overall Compliance: No	Severity Score: 12.5
Codes/Mitigation Info/Possible Solution		Field Measurements/Component Compliance

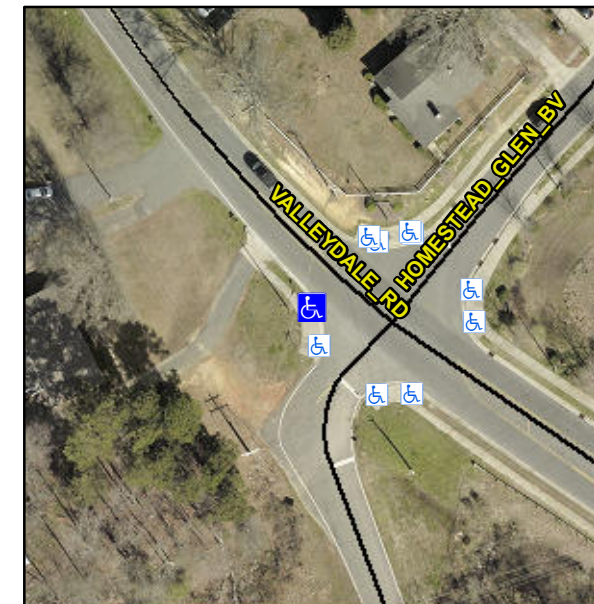
RP < 5%

Not Found, R304.3.2

Compliance	Description	Data	Compliance	Description	Data
N/A	Ramp Length LT (in)	51.0	N/A	Ramp Length RT (in)	60.0
Yes	Ramp Width LT (in)	57.0	Yes	Ramp Width RT (in)	59.0
No	Ramp Slope LT (%)	8.7	Yes	Ramp Slope RT (%)	6.5
Yes	Ramp XSlope LT (%)	1.3	Yes	Ramp XSlope RT (%)	0.6
N/A	Ramp Length (in)	47.0	Yes	Ramp Slope (%)	3.4
Yes	Ramp Width (in)	51.0	Yes	Ramp XSlope (%)	0.5
N/A	Flare Type LT	N/A	N/A	Flare Type RT	N/A
N/A	Flare Slope LT (%)	N/A	N/A	Flare Slope RT (%)	N/A
N/A	Flare Traversable LT?	N/A	N/A	Flare Traversable RT?	N/A
N/A	Landing Length (in)	N/A	N/A	DWS Provided?	N/A
N/A	Landing Width (in)	N/A	N/A	DWS Contrast?	N/A
N/A	Landing Slope (%)	N/A	N/A	DWS Length (in)	N/A
N/A	Landing X Slope (%)	N/A	N/A	DWS Full Width?	N/A
N/A	Landing Curb? (Y/N)	N/A	N/A	DWS Offset (in)	N/A
N/A	Shared Landing?	N/A			
N/A	Gutter Ponding?	N/A	N/A	Gutter Slope (%)	N/A
N/A	Gutter Lip Ht (in)	N/A	N/A	Gutter X Slope (%)	N/A
N/A	Painted X Walk1?	No	N/A	Painted X Walk2?	N/A

Remove & Replace Entire Ramp.

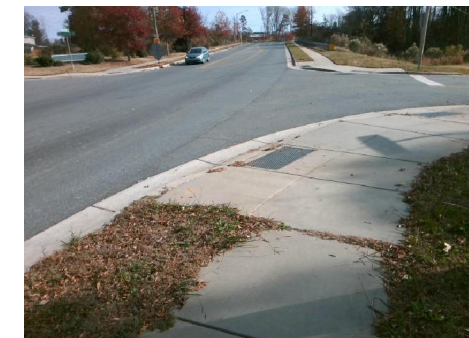
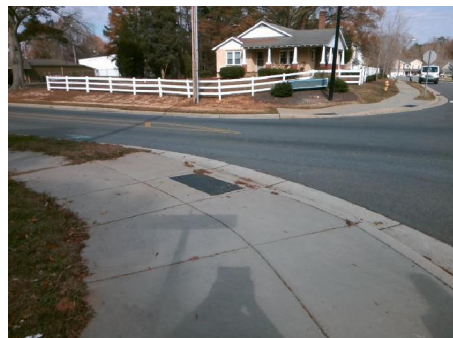
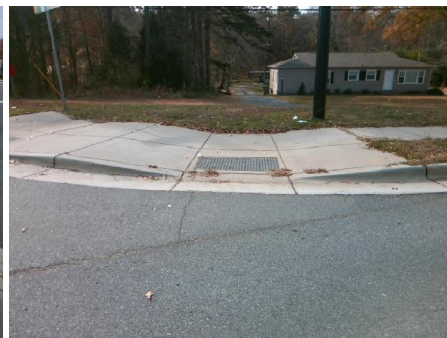
X Walk 1 Direction	To NE		X Walk 2 Direction	N/A
	X Walk 1 Width (in)	N/A		X Walk 2 Width (in)	N/A
	X Walk 1 Slope (%)	5.1		X Walk 2 Slope (%)	N/A
	X Walk 1 X Slope (%)	1.6		X Walk 2 X Slope (%)	N/A
N/A	Ramp inside XWalk1?	N/A	N/A	Ramp inside XWalk2?	N/A
	Road Slope (%)	N/A		Clear Space?	N/A
	Road X Slope (%)	N/A	N/A	Clear Space to XWalk (in)	N/A
			N/A	Any Obstruction?	N/A
				Obstruction Type	N/A
			N/A	Storm Grate/Utility Hazard?	N/A
				Storm Grate/Utility Type	N/A
					N/A
Yes	Surface Condition? (G/P)	Good			
	Curb Slope (%)	8.0
