## **Access Compliance Report Public Rights-of-Way** (Curb Ramps)

Intersection ID: 2898 Main Street: MISTY\_ARBOR\_WY Cross Street: WINTER\_PINE\_LN Location: ADA ID: 93DF051A3541 Ramp Type: Perp Initial Pass/Fail: Fail **Overall Compliance: No Severity Score:** 12.5

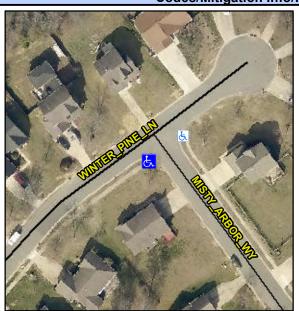
**MISTY ARBOR WY** Street 1 Name Stop Condition-Street 2 StopSign Street 2 Name N/A Stop Condition-Street 1 N/A Possible Solutions: Remove & Replace Entire Ramp. Surveyor Notes: N/A PROW/ADA: Not Found, R304.5.3

Field Measurements/Component Compliance					
Compliance Description Dat		Data	Comp	liance Description	Data
N/A	Ramp Length (in)	90.0	Yes	Ramp Slope (%)	6.6
Yes	Ramp Width (in)	72.0	No	Ramp XSlope (%)	6.1
N/A	Flare Type LT	N/A	N/A	Flare Type RT	N/A
N/A	Flare Slope LT (%)	N/A	N/A	Flare Slope RT (%)	N/A
N/A	Flare Traversable LT?	N/A	N/A	Flare Traversable RT?	N/A
N/A	Landing Length (in)	N/A	N/A	DWS Provided?	N/A
N/A	Landing Width (in)	N/A	N/A	DWS Contrast?	N/A
N/A	Landing Slope (%)	N/A	N/A	DWS Length (in)	N/A
N/A	Landing X Slope (%)	N/A	N/A	DWS Full Width?	N/A
N/A	Landing Curb? (Y/N)	N/A	N/A	DWS Offset (in)	N/A
N/A	Shared Landing?	N/A			
N/A	Gutter Ponding?	N/A	N/A	Gutter Slope (%)	N/A
N/A	Gutter Lip Ht (in)	N/A	N/A	Gutter X Slope (%)	N/A
N/A	Painted X Walk1?	No	N/A	Painted X Walk2?	N/A
	X Walk 1 Direction	To NE		X Walk 2 Direction	N/A
N/A	X Walk 1 Width (in)	N/A	N/A	X Walk 2 Width (in)	N/A
	X Walk 1 Slope (%)	0.4		X Walk 2 Slope (%)	N/A
