Access Compliance Report

Public Rights-of-Way

(Curb Ramps)

Intersection ID: 50605	Main Street: DENBUR_DR	Cross Street: RHODORA_RD	Location: NE
ADA ID: 9447A2F579AD	Ramp Type: Perp	Initial Pass/Fail: Fail	Overall Compliance: No
Severity Score: 33.75			
Codes/Mitigation Info/Possible Solution		Field Measurements/Component Compliance

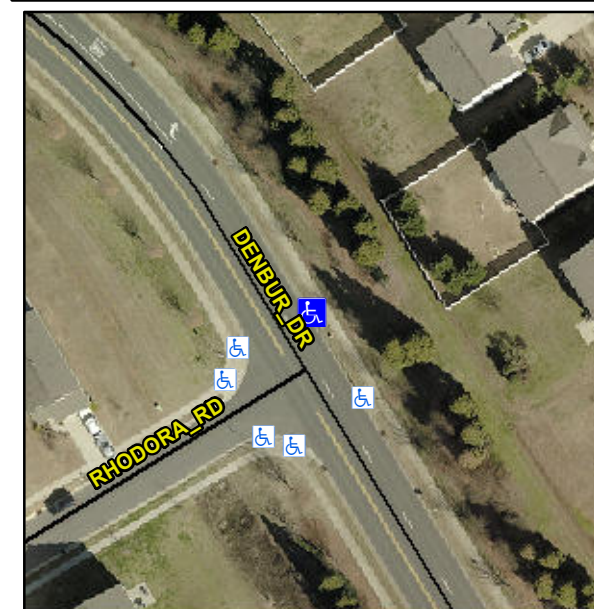
Not Found, R304.5.1, R304.2.2, R304.5.3

Compliance	Description	Data	Compliance	Description	Data
N/A	Ramp Length (in)	48.0	No	Ramp Slope (%)	10.2
No	Ramp Width (in)	47.5	No	Ramp XSlope (%)	5.1
N/A	Flare Type LT	N/A	N/A	Flare Type RT	N/A
N/A	Flare Slope LT (%)	N/A	N/A	Flare Slope RT (%)	N/A
N/A	Flare Traversable LT?	N/A	N/A	Flare Traversable RT?	N/A
N/A	Landing Length (in)	N/A	N/A	DWS Provided?	N/A
N/A	Landing Width (in)	N/A	N/A	DWS Contrast?	N/A
N/A	Landing Slope (%)	N/A	N/A	DWS Length (in)	N/A
N/A	Landing X Slope (%)	N/A	N/A	DWS Full Width?	N/A
N/A	Landing Curb? (Y/N)	N/A	N/A	DWS Offset (in)	N/A
N/A	Shared Landing?	N/A			
N/A	Gutter Ponding?	N/A	N/A	Gutter Slope (%)	N/A
N/A	Gutter Lip Ht (in)	N/A	N/A	Gutter X Slope (%)	N/A
N/A	Painted X Walk1?	No	N/A	Painted X Walk2?	N/A
	X Walk 1 Direction	To W		X Walk 2 Direction	N/A
N/A	X Walk 1 Width (in)	N/A	N/A	X Walk 2 Width (in)	N/A
	X Walk 1 Slope (%)	1.7		X Walk 2 Slope (%)	N/A
	X Walk 1 X Slope (%)	4.7		X Walk 2 X Slope (%)	N/A

Remove & Replace Entire Ramp.
