Access Compliance Report

Public Rights-of-Way

(Curb Ramps)

Intersection ID: 48304	Main Street: FAZENDA_DR	Cross Street: GANSO_LN	Location:	S
ADA ID: 9452DB05DEC9	Ramp Type: PerpDiag	Initial Pass/Fail: Fail	Overall Compliance: No	Severity Score: 37.5
Codes/Mitigation Info/Possible Solution		Field Measurements/Component Compliance

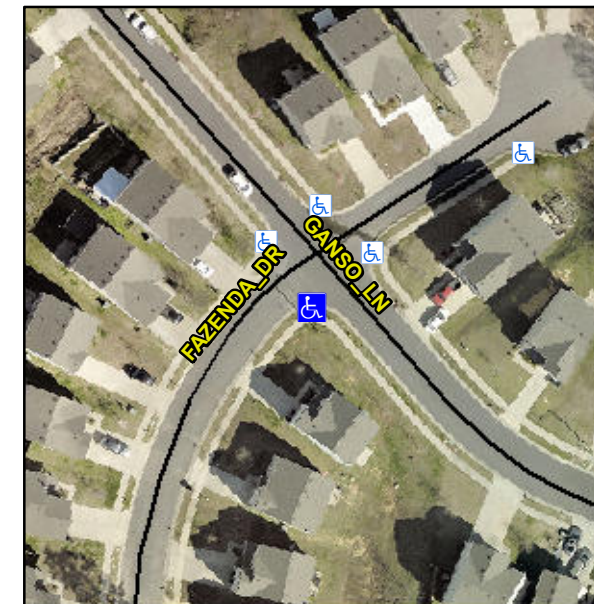
Not Found, R304.2.2, R304.5.3

Compliance	Description	Data	Compliance	Description	Data
N/A	Ramp Length (in)	48.5	No	Ramp Slope (%)	8.5
Yes	Ramp Width (in)	48.0	No	Ramp XSlope (%)	12.0
N/A	Flare Type LT	N/A	N/A	Flare Type RT	N/A
N/A	Flare Slope LT (%)	N/A	N/A	Flare Slope RT (%)	N/A
N/A	Flare Traversable LT?	N/A	N/A	Flare Traversable RT?	N/A
N/A	Landing Length (in)	N/A	N/A	DWS Provided?	N/A
N/A	Landing Width (in)	N/A	N/A	DWS Contrast?	N/A
N/A	Landing Slope (%)	N/A	N/A	DWS Length (in)	N/A
N/A	Landing X Slope (%)	N/A	N/A	DWS Full Width?	N/A
N/A	Landing Curb? (Y/N)	N/A	N/A	DWS Offset (in)	N/A
N/A	Shared Landing?	N/A			
N/A	Gutter Ponding?	N/A	N/A	Gutter Slope (%)	N/A
N/A	Gutter Lip Ht (in)	0.5	N/A	Gutter X Slope (%)	N/A
N/A	Painted X Walk1?	No	N/A	Painted X Walk2?	No
	X Walk 1 Direction	To NE		X Walk 2 Direction	To NW
N/A	X Walk 1 Width (in)	N/A	N/A	X Walk 2 Width (in)	N/A
	X Walk 1 Slope (%)	7.5		X Walk 2 Slope (%)	2.3
	X Walk 1 X Slope (%)	6.7		X Walk 2 X Slope (%)	10.9

N/A	Ramp inside XWalk1?	N/A	N/A	Ramp inside XWalk2?	N/A
	Road Slope (%)	11.4	N/A	Clear Space?	N/A
	Road X Slope (%)	3.4	N/A	Clear Space to XWalk (in)	N/A
N/A	Any Obstructions?	N/A	N/A	Storm Grate/Utility Hazard?	N/A
	Obstruction Type			Storm Grate/Utility Type	
		N/A			N/A
		Yes		Surface Condition? (G/P)	Good

Possible Solutions:

Remove & Replace Curb Ramp With Two New Directional Ramps or Equivalent.
