Access Compliance Report

Public Rights-of-Way

(Curb Ramps)

| Intersection ID: 14294 | Main Street: EAST_BV | Cross Street: EUCLID_AV | Location: SW |

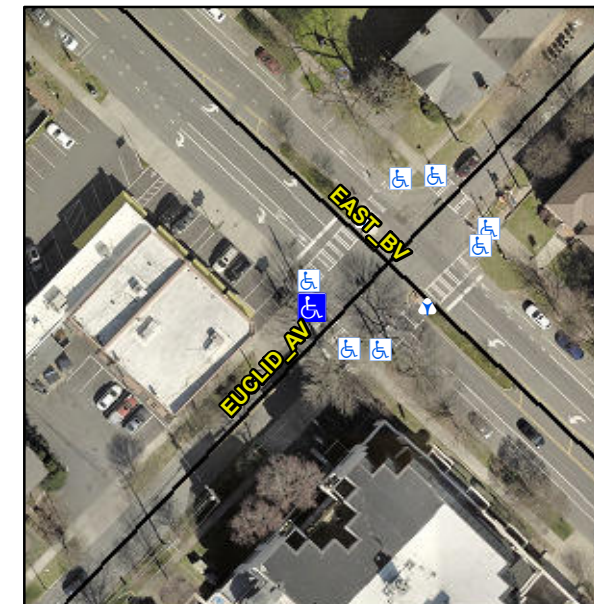
| ADA ID: 94E5C053F6A5 | Ramp Type: Directional1 | Initial Pass/Fail: Fail | Overall Compliance: No |
| | | Severity Score: 12.5 | |

R304.5.3

| Compliance | Description | Data | Compliance | Description | Data |
|---|---|---|---|---|---|
| No | Ramp XSlope (%) | 5.9 | | | |

Remove & Replace Entire Ramp.
