# Access Compliance Report

### (Curb Ramps)

| Intersection ID: 48948 | Main Street: BIRCHLEY_CR | Cross Street: DAVID_JENNINGS_AV | Location: NW |
| ADA ID: 95A7AD70C847 | Ramp Type: Perp | Initial Pass/Fail: Fail | Overall Compliance: No |

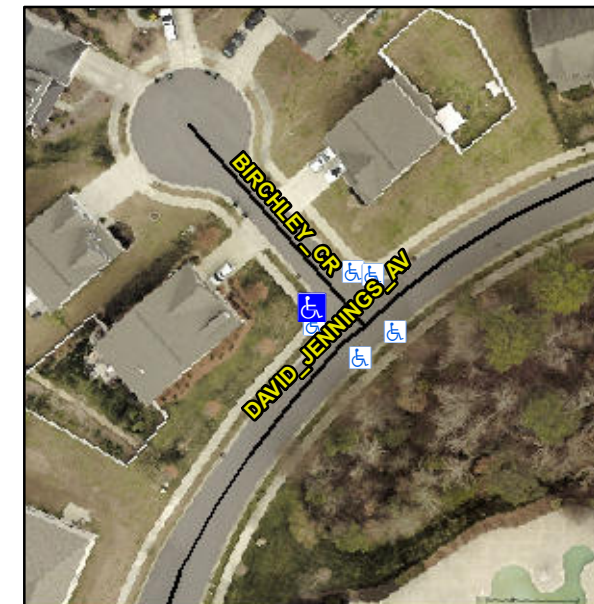
| Severity Score: 8.75 | | | |

**Not Found, R304.5.1**

| Compliance | Description | Data | Compliance | Description | Data |
|---|---|---|---|---|---|
| No | Ramp Width (in) | 45.5 | Yes | Ramp XSlope (%) | 1.4 |

**Remove & Replace Entire Ramp.**
