## Access Compliance Report Public Rights-of-Way (Curb Ramps)

Intersection ID: 14959 Main Street: EASTLAND\_MALL\_DR Cross Street: N/A Location: W

ADA ID: 95B8C44FCC24 Ramp Type: Combination1 Initial Pass/Fail: Fail Overall Compliance: No Severity Score: 22.5

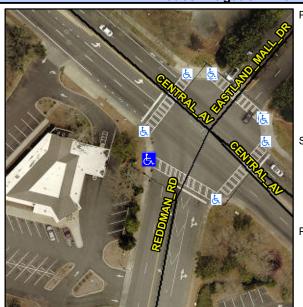
LT RP < 5%

Not Found, R304.5.1, R304.5.3, R304.3.2

Compliance Description Data		Data		liance Description	Data
N/A	Ramp Length LT (in)	65.0	N/A	Ramp Length RT (in)	65.5
Yes	Ramp Width LT (in)	72.0	Yes	Ramp Width RT (in)	72.0
Yes	Ramp Slope LT (%)	3.1	No	Ramp Slope RT (%)	10.1
Yes	Ramp XSlope LT (%)	0.8	No	Ramp XSlope RT (%)	2.8
N/A	Ramp Length (in)	72.0	Yes	Ramp Slope (%)	6.3
No	Ramp Width (in)	47.0	No	Ramp XSlope (%)	2.2
N/A	Flare Type LT	N/A	N/A	Flare Type RT	N/A
N/A	Flare Slope LT (%)	N/A	N/A	Flare Slope RT (%)	N/A
N/A	Flare Traversable LT?	N/A	N/A	Flare Traversable RT?	N/A
N/A	Landing Length (in)	N/A	N/A	DWS Provided?	N/A
N/A	Landing Width (in)	N/A	N/A	DWS Contrast?	N/A
N/A	Landing Slope (%)	N/A	N/A	DWS Length (in)	N/A
N/A	Landing X Slope (%)	N/A	N/A	DWS Full Width?	N/A
N/A	Landing Curb? (Y/N)	N/A	N/A	DWS Offset (in)	N/A
N/A	Shared Landing?	N/A			
N/A	Gutter Ponding?	N/A	N/A	Gutter Slope (%)	N/A
N/A	Gutter Lip Ht (in)	N/A	N/A	Gutter X Slope (%)	N/A
N/A	Painted X Walk1?	Yes	N/A	Painted X Walk2?	N/A

Remove & Replace Entire Ramp.
