Access Compliance Report

Public Rights-of-Way

(Curb Ramps)

Intersection ID: 46816	Main Street: CYPRESS_VIEW_DR	Cross Street: ARBOR_VISTA_DR	Location: SE
ADA ID: 95B9F53B56A8	Ramp Type: PerpDiag	Initial Pass/Fail: Fail	Overall Compliance: No
			Severity Score: 21.25

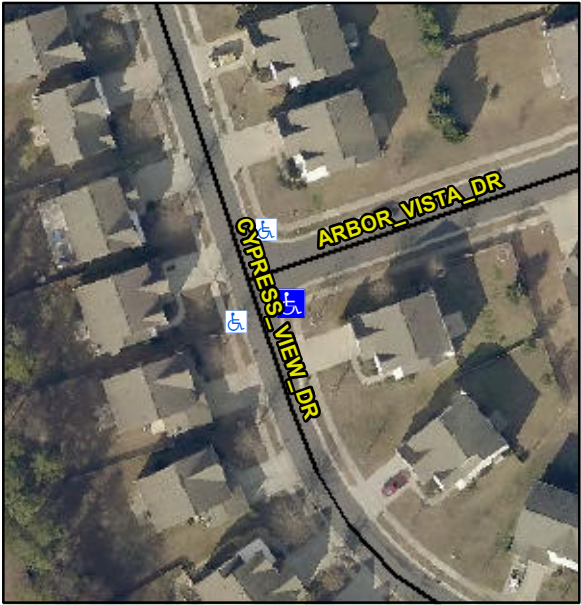
Possible Solutions:		Compliance	Description	Data
	Remove & Replace Curb Ramp With Two New Directional Ramps or Equivalent.		No	Ramp Length (in)	46.0
			No	Ramp Width (in)	39.0
			N/A	Flare Type LT	N/A
			N/A	Flare Slope LT (%)	N/A
			N/A	Flare Traversable LT?	N/A
			N/A	Landing Length (in)	N/A
			N/A	Landing Width (in)	N/A
			N/A	Landing Slope (%)	N/A
			N/A	Landing X Slope (%)	N/A
<p>Surveyor Notes:</p> <p>N/A</p> <p>PROW/ADA:</p> <p>Not Found, R304.5.1, R304.2.2</p>			N/A	Flare Type RT	N/A
			N/A	Flare Slope RT (%)	N/A
			N/A	Flare Traversable RT?	N/A
			N/A	DWS Provided?	N/A
			N/A	DWS Contrast?	N/A
			N/A	DWS Length (in)	N/A
			N/A	DWS Full Width?	N/A
			N/A	DWS Offset (in)	N/A
			N/A	Gutter Ponding?	N/A
			N/A	Gutter Lip Ht (in)	N/A
			No	Painted X Walk1?	No
			To N	X Walk 1 Direction	To W
			N/A	X Walk 1 Width (in)	N/A

2.8	X Walk 1 Slope (%)	2.9
			1.6	X Walk 1 X Slope (%)	2.6
			N/A	Ramp inside XWalk1?	N/A
			0.9	Road Slope (%)	N/A
			3.4	Road X Slope (%)	N/A
			N/A	Any Obstructions?	N/A
				Obstruction Type	
Total Cost:			\$ 3200.00		
			N/A		N/A
			Yes	Surface Condition? (G/P)	Good
