## Access Compliance Report Public Rights-of-Way (Curb Ramps)

Intersection ID: 6379Main Street: COLLINS\_STCross Street: LAKE\_RDLocation:SEADA ID: 9603466E57D4Ramp Type: PerpInitial Pass/Fail: FailOverall Compliance: NoSeverity Score:22.5

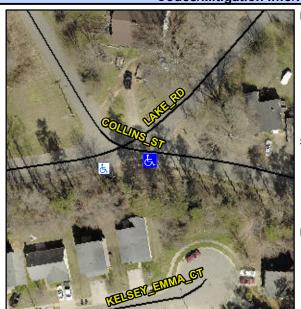
- a55/F	all. Fall Overall	Compilar	ice. N	o Severity Score.	22.		
Field Measurements/Component Compliance							
Comp	liance Description	Data	Comp	liance Description	Data		
N/A	Ramp Length (in)	48.0	No	Ramp Slope (%)	8.9		
No	Ramp Width (in)	47.5	Yes	Ramp XSlope (%)	2.6		
N/A	Flare Type LT	N/A	N/A	Flare Type RT	N/A		
N/A	Flare Slope LT (%)	N/A	N/A	Flare Slope RT (%)	N/A		
N/A	Flare Traversable LT?	N/A	N/A	Flare Traversable RT?	N/A		
N/A	Landing Length (in)	N/A	N/A	DWS Provided?	N/A		
N/A	Landing Width (in)	N/A	N/A	DWS Contrast?	N/A		
N/A	Landing Slope (%)	N/A	N/A	DWS Length (in)	N/A		
N/A	Landing X Slope (%)	N/A	N/A	DWS Full Width?	N/A		
N/A	Landing Curb? (Y/N)	N/A	N/A	DWS Offset (in)	N/A		
N/A	Shared Landing?	N/A					
N/A	Gutter Ponding?	N/A	N/A	Gutter Slope (%)	N/A		
N/A	Gutter Lip Ht (in)	N/A	N/A	Gutter X Slope (%)	N/A		
N/A	Painted X Walk1?	No	N/A	Painted X Walk2?	N/A		
	X Walk 1 Direction	To NW		X Walk 2 Direction	N/A

N/A	X Walk 1 Width (in)	N/A	N/A	X Walk 2 Width (in)	N/A		
	X Walk 1 Slope (%)	5.3		X Walk 2 Slope (%)	N/A		
	X Walk 1 X Slope (%)	3.4		X Walk 2 X Slope (%)	N/A		
N/A	Ramp inside XWalk1?	N/A	N/A	Ramp inside XWalk2?	N/A		
	Road Slope (%)	N/A	N/A	Clear Space?	N/A		
	Road X Slope (%)	N/A	N/A	Clear Space to XWalk (in)	N/A		
N/A	Any Obstructions?	N/A	N/A	Storm Grate/Utility Hazard?	N/A		
	Obstruction Type		l	Storm Grate/Utility Type			
		N/A			N/A		
			Yes	Surface Condition? (G/P)	Good

Possible Solutions:	
Remove & Replace Entire Ramp.	
Company Notes	
Surveyor Notes:	
N/A	
PROW/ADA:	
Not Found, R304.5.1, R304.2.2	
, , , ,
