## Access Compliance Report Public Rights-of-Way (Curb Ramps)

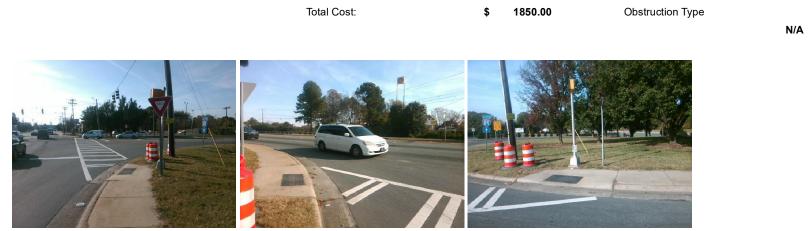
I	
Intersection ID: 7724	Main Street: BEATTIES_FORD_RD			treet:	N_I-85_EXIT_37_RA			Location:	NW	
ADA ID: 967E65E6BA3C	Ramp Type: Perp			Initial Pass/Fail: Fail Overall Compliance: No			o Severity Score:	10		
Codes/Mitigation Info/Possible Solution				Field Measurements/Component Compliance						
	CONTRACTOR OF A	Possible Solutions:					Compliance Description		Data	
1 1000		Remove & Replace Entire Ramp		N/A	Ramp Length (in)	68.0	Yes	Ramp Slope (%)	6.8

•	No	Ramp Width (in)	46.5	No	Ramp XSlope (%)	4.3	
				N/A	Flare Type LT	N/A	N/A	Flare Type RT	N/A	
	1 . 1997			N/A	Flare Slope LT (%)	N/A	N/A	Flare Slope RT (%)	N/A	
tes he :				N/A	Flare Traversable LT?	N/A	N/A	Flare Traversable RT?	N/A	
				N/A	Landing Length (in)	N/A	N/A	DWS Provided?	N/A	
A AND AND A		Surveyor Notes:		N/A	Landing Width (in)	N/A	N/A	DWS Contrast?	N/A	
		N/A		N/A	Landing Slope (%)	N/A	N/A	DWS Length (in)	N/A	
				N/A	Landing X Slope (%)	N/A	N/A	DWS Full Width?	N/A	
日本的人口				N/A	Landing Curb? (Y/N)	N/A	N/A	DWS Offset (in)	N/A	
TIL ST.	Level 1			N/A	Shared Landing?	N/A		( )		
MARIE ECHAN	- I Martin	PROW/ADA:		N/A	Gutter Ponding?	N/A	N/A	Gutter Slope (%)	N/A	
The state of the	1 c 1 6	R304.5.1, R304.5.3		N/A	Gutter Lip Ht (in)	N/A	N/A	Gutter X Slope (%)	N/A	
The second se	6	1004.0.1, 1004.0.0		N/A	Painted X Walk1?	Yes	N/A	Painted X Walk2?	N/A	
	5 TIME				X Walk 1 Direction	To S		X Walk 2 Direction	N/A
