## Access Compliance Report Public Rights-of-Way (Curb Ramps)

Intersection ID: N/AMain Street: TYVOLA\_RDCross Street: I-77Location:SEADA ID: 96856163B4E1Ramp Type: BlendTrans1Initial Pass/Fail: PassOverall Compliance: NoSeverity Score: 10.25

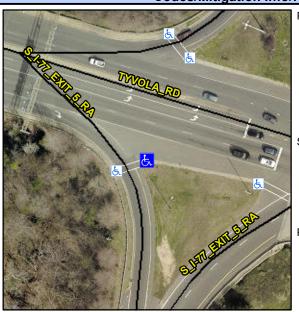
Comp	liance Description	Data	Comp	liance Description	Data
N/A	Ramp Length (in)	84.0	Yes	BlendTrans Slope (%)	2.3
Yes	Ramp Width (in)	60.0	Yes	BlendTrans XSlope (%)	2.1
N/A	Flare Type LT	None	N/A	Flare Type RT	None
N/A	Flare Slope LT (%)	N/A	N/A	Flare Slope RT (%)	N/A
N/A	Flare Traversable LT?	N/A	N/A	Flare Traversable RT?	N/A
Yes	Landing Length (in)	60.0	No	DWS Provided?	No
Yes	Landing Width (in)	60.0	N/A	DWS Contrast?	No
No	Landing Slope (%)	2.4	N/A	DWS Length (in)	N/A
Yes	Landing X Slope (%)	1.9	N/A	DWS Full Width?	No
N/A	Landing Curb? (Y/N)	No	N/A	DWS Offset (in)	N/A
N/A	Shared Landing?	No			
Yes	Gutter Ponding?	No	Yes	Gutter Slope (%)	2.3
Yes	Gutter Lip Ht (in)	0.0	No	Gutter X Slope (%)	4.3
N/A	Painted X Walk1?	Yes	N/A	Painted X Walk2?	N/A
	X Walk 1 Direction	To W		X Walk 2 Direction	N/A
	X Walk 1 Width (in)	71.5		X Walk 2 Width (in)	N/A
	X Walk 1 Slope (%)	0.6		X Walk 2 Slope (%)	N/A
	X Walk 1 X Slope (%)	2.7		X Walk 2 X Slope (%)	N/A

Yes	Ramp inside XWalk1?	Yes	N/A	Ramp inside XWalk2?	N/A
	Road Slope (%)	2.7		Clear Space?	Yes
	Road X Slope (%)	0.6	N/A	Clear Space to XWalk (in)	N/A
Yes	Any Obstructions?	No	Yes	Storm Grate/Utility Hazard?	No
	Obstruction Type		l	Storm Grate/Utility Type	
		N/A			N/A
			Yes	Surface Condition? (G/P)	Good
			Yes	Curb Slope (%)	0.2

Remove & Replace Curb Ramp With
Two New Directional Ramps or
Equivalent. Remove & Replace
Gutter.
