# Access Compliance Report

## Public Rights-of-Way

| Intersection ID: 50942 | Main Street: CEDAR_WALK_LN | Cross Street: DUNAVERTY_PL | Location: NE |
| ADA ID: 9747539E9EF6 | Ramp Type: PerpDiag | Initial Pass/Fail: Fail | Overall Compliance: No |

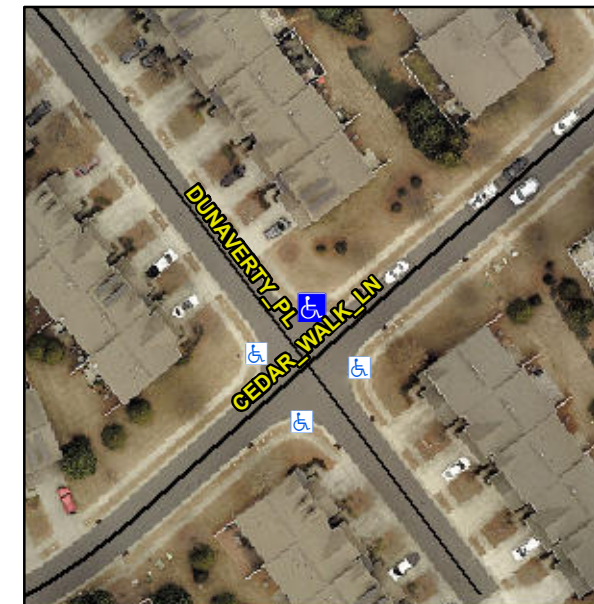
**Not Found, R304.5.1, R304.5.3**

| Compliance | Description | Data | Compliance | Description | Data |
|---|---|---|---|---|---|
| No | Ramp Width (in) | 47.5 | No | Ramp XSlope (%) | 9.4 |

**Remove & Replace Curb Ramp With Two New Directional Ramps or Equivalent.**
