Access Compliance Report Public Rights-of-Way (Curb Ramps)

Intersection ID: 53962 Main Street: LILAC TREE AV Cross Street: DENBUR DR Location: S **Overall Compliance: No Severity Score:** 10 ADA ID: 976B81CDC9AD Ramp Type: Combination2 Initial Pass/Fail: Fail

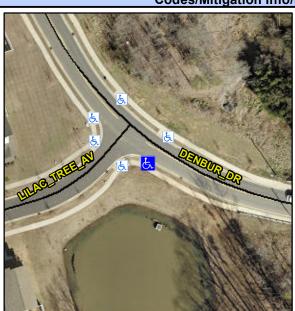
Compliance Description Possible Solutions: N/A Remove & Replace Entire Ramp. N/A N/A N/A N/A No Surveyor Notes: N/A LT RP < 5% N/A N/A N/A N/A PROW/ADA: N/A Not Found, R304.5.1, R304.5.3 N/A N/A
