Access Compliance Report Public Rights-of-Way (Curb Ramps)

Intersection ID: 10013090 Main Street: BELMONT_AV Cross Street: N/A Location: N

ADA ID: 97B3FE0EAD60 Ramp Type: Perp Initial Pass/Fail: Fail Overall Compliance: No Severity Score: 8.75

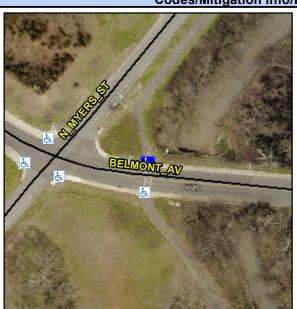
| /Possible Solution | | | | |
|---|--|--|--|--|
| R304.5.1 | | | | |

| Comp | liance Description | Data | | liance Description | Data |
|---|---|---|---|---|---|
| No | Ramp Width (in) | 47.0 | Yes | Ramp XSlope (%) | 1.3 |

| /Possible Solution | | | | |
|---|--|--|--|--|
| Remove & Replace Entire Ramp. | | | | |
