# Access Compliance Report

## Public Rights-of-Way

| Intersection ID: 24904 | Main Street: PROVIDENCE_RD | Cross Street: PINEVILLE-MATTHEWS_RD | Location: NW |
| ADA ID: 97F37ABC04EA | Ramp Type: Perp | Initial Pass/Fail: Fail | Overall Compliance: No |

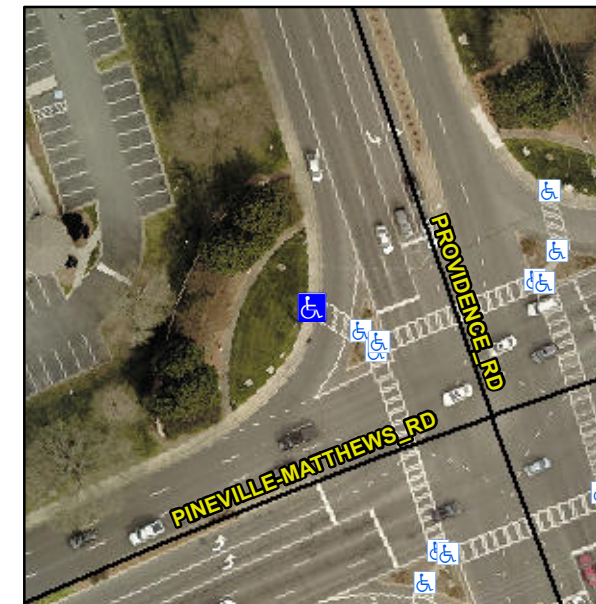
**Not Found, R304.2.2**

| Compliance | Description | Data | Compliance | Description | Data |
|---|---|---|---|---|---|
| N/A | Ramp Length (in) | 60.0 | No | Ramp Slope (%) | 9.0 |

**Remove & Replace Entire Ramp.**
