Access Compliance Report Public Rights-of-Way (Curb Ramps)

Intersection ID: 8515 Main Street: ATANDO_AV Cross Street: STATESVILLE_AV Location: SE Severity Score: **Overall Compliance: No** ADA ID: 97FD20B6C907 Ramp Type: Perp Initial Pass/Fail: Fail 22.5

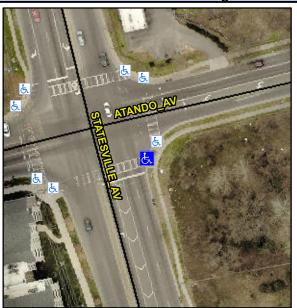
| 4 | TOURIST CONTROL | |
|---|---|---|
| 9 | Not Found, R304.5.1, R304.2.2 | N |

| Field Measurements/Component Compliance | | | | | | | |
|---|---|---|---|---|---|---|--|
| N/A | Ramp Length (in) | 60.0 | No | Ramp | Slope (%) | 10.1 | |
| No | Ramp Width (in) | 42.0 | Yes | Ramp | XSlope (%) | 2.7 | |

| 4 | TOURIST CONTROL | |
|---|---|---|
| - 600 | Remove & Replace Entire Ramp. | N |
