Access Compliance Report

Public Rights-of-Way

(Curb Ramps)

Intersection ID: 9818	Main Street: EDGEWOOD_RD	Cross Street: LOCH_LEVEN_ST	Location:	N
ADA ID: 982D4055B449	Ramp Type: Perp	Initial Pass/Fail: Fail	Overall Compliance: No	Severity Score: 35
Codes/Mitigation Info/Possible Solution		Field Measurements/Component Compliance

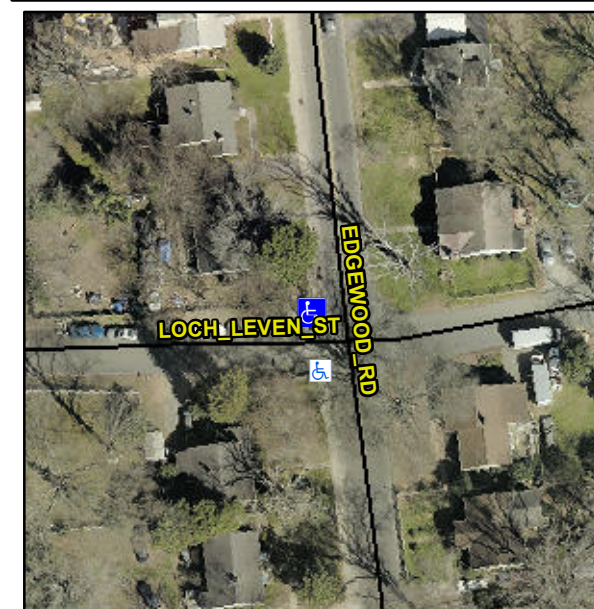
Not Found, R304.5.1

Compliance	Description	Data	Compliance	Description	Data
N/A	Ramp Length (in)	68.0	Yes	Ramp Slope (%)	7.3
No	Ramp Width (in)	27.0	Yes	Ramp XSlope (%)	0.9
N/A	Flare Type LT	N/A	N/A	Flare Type RT	N/A
N/A	Flare Slope LT (%)	N/A	N/A	Flare Slope RT (%)	N/A
N/A	Flare Traversable LT?	N/A	N/A	Flare Traversable RT?	N/A
N/A	Landing Length (in)	N/A	N/A	DWS Provided?	N/A
N/A	Landing Width (in)	N/A	N/A	DWS Contrast?	N/A
N/A	Landing Slope (%)	N/A	N/A	DWS Length (in)	N/A
N/A	Landing X Slope (%)	N/A	N/A	DWS Full Width?	N/A
N/A	Landing Curb? (Y/N)	N/A	N/A	DWS Offset (in)	N/A
N/A	Shared Landing?	N/A			
N/A	Gutter Ponding?	N/A	N/A	Gutter Slope (%)	N/A
N/A	Gutter Lip Ht (in)	N/A	N/A	Gutter X Slope (%)	N/A
N/A	Painted X Walk1?	No	N/A	Painted X Walk2?	N/A
	X Walk 1 Direction	To S		X Walk 2 Direction	N/A
N/A	X Walk 1 Width (in)	N/A	N/A	X Walk 2 Width (in)	N/A
	X Walk 1 Slope (%)	0.2		X Walk 2 Slope (%)	N/A
	X Walk 1 X Slope (%)	2.5		X Walk 2 X Slope (%)	N/A

N/A	Ramp inside XWalk1?	N/A	N/A	Ramp inside XWalk2?	N/A
	Road Slope (%)	N/A	N/A	Clear Space?	N/A
	Road X Slope (%)	N/A	N/A	Clear Space to XWalk (in)	N/A
N/A	Any Obstructions?	N/A	N/A	Storm Grate/Utility Hazard?	N/A
	Obstruction Type			Storm Grate/Utility Type	
		N/A			N/A
			Yes	Surface Condition? (G/P)	Good

Remove & Replace Entire Ramp.
