# Access Compliance Report

## Public Rights-of-Way

| Intersection ID: 54660 | Main Street: WISDOM_LN | Cross Street: BAUCOM_RD | Location: W |
| ADA ID: 98D729BEBA36 | Ramp Type: Perp | Initial Pass/Fail: Fail | Overall Compliance: No |

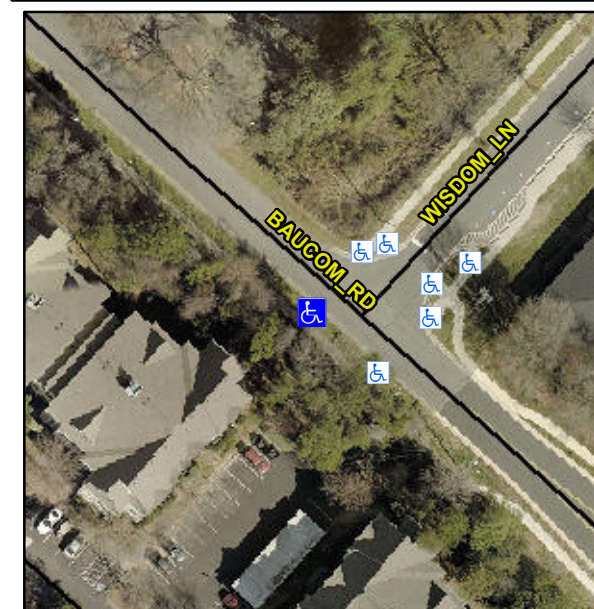
| Severity Score: 13.75 | | | |

**R304.2.2**

| Compliance | Description | Data | Compliance | Description | Data |
|---|---|---|---|---|---|
| N/A | Ramp Length (in) | 98.0 | No | Ramp Slope (%) | 8.9 |

**Remove & Replace Entire Ramp.**

**\$ 1850.00**
