## **Access Compliance Report Public Rights-of-Way** (Curb Ramps)

Main Street: FONTANA AV Intersection ID: 10198 **Cross Street: REMBERT CT** Location: NE Initial Pass/Fail: Fail **Overall Compliance: No** ADA ID: 98F766C02222 Ramp Type: Combination2 **Severity Score:** 72.5

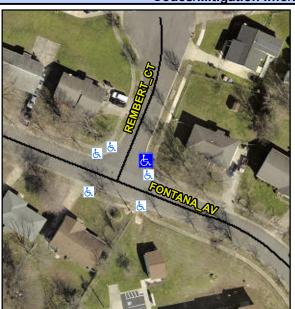
Street 1 Name StopSign REMBERT CT Stop Condition-Street 1 Street 2 Name N/A Stop Condition-Street 2 N/A Possible Solutions: Compliance Description N/A Remove & Replace Entire Ramp. N/A N/A N/A N/A Yes Surveyor Notes: N/A LT RP < 5% N/A N/A N/A N/A PROW/ADA: N/A Not Found, R304.5.1, R304.5.3, N/A R304.3.2 N/A N/A N/A N/A N/A
