Access Compliance Report

Public Rights-of-Way

(Curb Ramps)

Intersection ID: 2765	Main Street: BEAUVISTA_DR	Cross Street: HICKORY_COVE_LN	Location: SE
ADA ID: 99B1DC2F2B70	Ramp Type: PerpDiag	Initial Pass/Fail: Fail	Overall Compliance: No
			Severity Score: 33.75

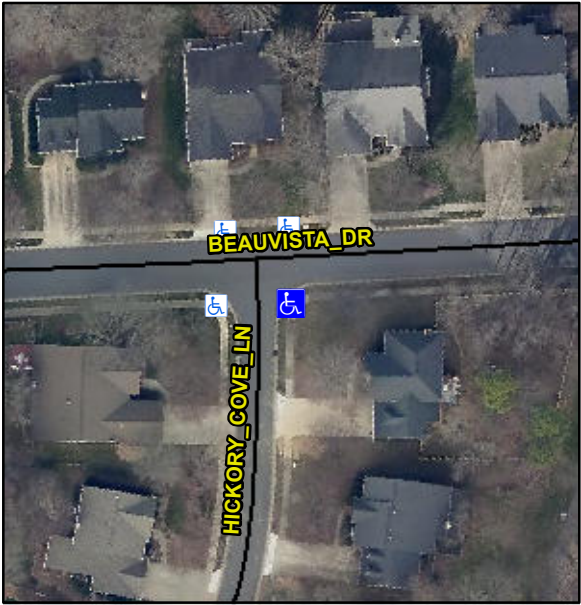
Possible Solutions:		Compliance	Description	Data
	Remove & Replace Curb Ramp With Two New Directional Ramps or Equivalent.		Yes	Ramp Length (in)	5.3
			No	Ramp Width (in)	10.2
			N/A	Flare Type LT	N/A
			N/A	Flare Slope LT (%)	N/A
			N/A	Flare Traversable LT?	N/A
			N/A	Landing Length (in)	N/A
			N/A	Landing Width (in)	N/A
			N/A	Landing Slope (%)	N/A
			N/A	Landing X Slope (%)	N/A
<p>Surveyor Notes:</p> <p>N/A</p> <p>PROW/ADA:</p> <p>Not Found, R304.5.1, R304.5.3</p>			N/A	Flare Type RT	N/A
			N/A	Flare Slope RT (%)	N/A
			N/A	Flare Traversable RT?	N/A
			N/A	DWS Provided?	N/A
			N/A	DWS Contrast?	N/A
			N/A	DWS Length (in)	N/A
			N/A	DWS Full Width?	N/A
			N/A	DWS Offset (in)	N/A
			N/A	Gutter Ponding?	N/A
			N/A	Gutter Lip Ht (in)	N/A
			No	Painted X Walk1?	No
				X Walk 1 Direction	To N
			N/A	X Walk 1 Width (in)	N/A

7.5	X Walk 1 Slope (%)	9.6
			7.8	X Walk 1 X Slope (%)	3.0
			N/A	Ramp inside XWalk1?	N/A
			8.2	Road Slope (%)	N/A
			6.0	Road X Slope (%)	N/A
			N/A	Any Obstructions?	N/A
				Obstruction Type	
Total Cost: \$ 3200.00			N/A	Storm Grate/Utility Hazard?	N/A
			N/A	Storm Grate/Utility Type	N/A
			Yes	Surface Condition? (G/P)	Good
