Access Compliance Report

Public Rights-of-Way

(Curb Ramps)

Intersection ID: 8697	Main Street: HOLLAND_AV	Cross Street: ISENHOUR_ST	Location: NW
ADA ID: 99F019608B3A	Ramp Type: PerpDiag	Initial Pass/Fail: Fail	Overall Compliance: No
		Severity Score: 33.75

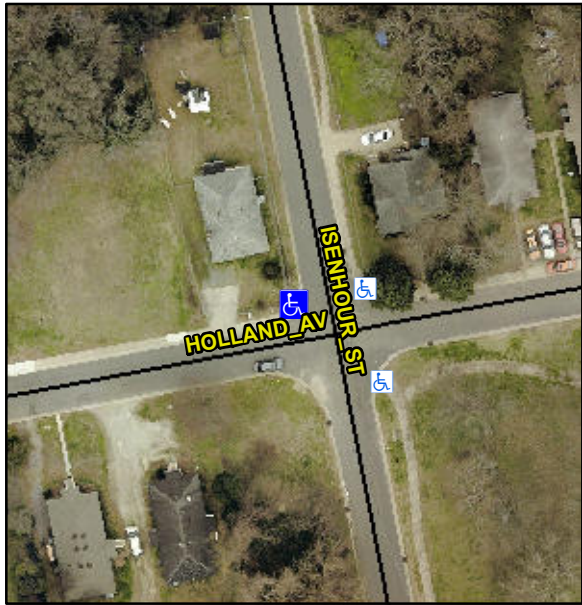
Possible Solutions:						
	Remove & Replace Curb Ramp With Two New Directional Ramps or Equivalent.	N/A	Ramp Length (in)	47.0	Yes	Ramp Slope (%)	5.0
		No	Ramp Width (in)	38.0	No	Ramp XSlope (%)	13.3
		N/A	Flare Type LT	N/A	N/A	Flare Type RT	N/A
		N/A	Flare Slope LT (%)	N/A	N/A	Flare Slope RT (%)	N/A
		N/A	Flare Traversable LT?	N/A	N/A	Flare Traversable RT?	N/A
		N/A	Landing Length (in)	N/A	N/A	DWS Provided?	N/A
		N/A	Landing Width (in)	N/A	N/A	DWS Contrast?	N/A
		N/A	Landing Slope (%)	N/A	N/A	DWS Length (in)	N/A
		N/A	Landing X Slope (%)	N/A	N/A	DWS Full Width?	N/A
<p>Surveyor Notes:</p> <p>N/A</p> <p>PROW/ADA:</p> <p>Not Found, R304.5.1, R304.5.3</p>		N/A	Landing Curb? (Y/N)	N/A	N/A	DWS Offset (in)	N/A
		N/A	Shared Landing?	N/A			
		N/A	Gutter Ponding?	N/A	N/A	Gutter Slope (%)	N/A
		N/A	Gutter Lip Ht (in)	N/A	N/A	Gutter X Slope (%)	N/A

N/A	Painted X Walk1?	No	N/A	Painted X Walk2?	No
			X Walk 1 Direction	To S		X Walk 2 Direction	To E
		N/A	X Walk 1 Width (in)	N/A	N/A	X Walk 2 Width (in)	N/A
			X Walk 1 Slope (%)	N/A		X Walk 2 Slope (%)	1.5
			X Walk 1 X Slope (%)	N/A		X Walk 2 X Slope (%)	10.1
		N/A	Ramp inside XWalk1?	N/A	N/A	Ramp inside XWalk2?	N/A
			Road Slope (%)	N/A	N/A	Clear Space?	N/A
			Road X Slope (%)	N/A	N/A	Clear Space to XWalk (in)	N/A
		N/A	Any Obstructions?	N/A	N/A	Storm Grate/Utility Hazard?	N/A
			Obstruction Type			Storm Grate/Utility Type	
					N/A		N/A
					Yes	Surface Condition? (G/P)	Good
	Total Cost:		\$	3200.00
