Access Compliance Report Public Rights-of-Way (Curb Ramps)

Intersection ID: 53349 Main Street: SAPPHIRE_HILL_LN Cross Street: N/A Location: SE

ADA ID: 9A1EE5C7FFF8 Ramp Type: Perp Initial Pass/Fail: Fail Overall Compliance: No Severity Score: 1.25

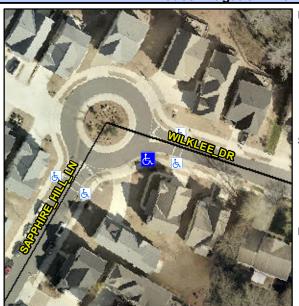
| 71 CCCIBIC CCIGNON | | i ioia iiio |
|---|---|---|
| Not Found, R304.5.3 | N/A | Gutter Lip Ht (in) |

| N/A | Ramp Length (in) | 47.5 | Yes | Ramp Slope (%) | 6.5 |
|---|---|---|---|---|---|
| Yes | Ramp Width (in) | 59.0 | No | Ramp XSlope (%) | 2.9 |

| 71 CCCIBIC CCIGNON | | i ioia iiio |
|---|---|---|
| Remove & Replace Entire Ramp. | N/A | Ramp Length (in) |
