Access Compliance Report Public Rights-of-Way (Curb Ramps)

Intersection ID: 21939 Main Street: PARK_RD Cross Street: RIVERBEND_RD Location: SE

ADA ID: 9A314524925E Ramp Type: PerpDiag Initial Pass/Fail: Fail Overall Compliance: No Severity Score: 25

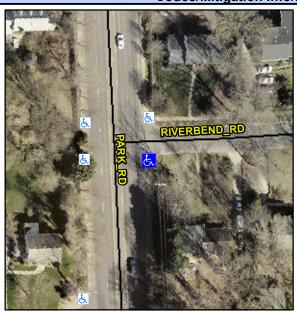
Not Found, R304.2.2, R304.5.3

Field Measurements/Component Compliance					
Compliance Description		Data	Compliance Description		Data
N/A	Ramp Length (in)	59.0	No	Ramp Slope (%)	8.9
Yes	Ramp Width (in)	48.0	No	Ramp XSlope (%)	5.2
N/A	Flare Type LT	N/A	N/A	Flare Type RT	N/A
N/A	Flare Slope LT (%)	N/A	N/A	Flare Slope RT (%)	N/A
N/A	Flare Traversable LT?	N/A	N/A	Flare Traversable RT?	N/A
N/A	Landing Length (in)	N/A	N/A	DWS Provided?	N/A
N/A	Landing Width (in)	N/A	N/A	DWS Contrast?	N/A
N/A	Landing Slope (%)	N/A	N/A	DWS Length (in)	N/A
N/A	Landing X Slope (%)	N/A	N/A	DWS Full Width?	N/A
N/A	Landing Curb? (Y/N)	N/A	N/A	DWS Offset (in)	N/A
N/A	Shared Landing?	N/A			
N/A	Gutter Ponding?	N/A	N/A	Gutter Slope (%)	N/A
N/A	Gutter Lip Ht (in)	N/A	N/A	Gutter X Slope (%)	N/A
N/A	Painted X Walk1?	No	N/A	Painted X Walk2?	No
	X Walk 1 Direction	To N		X Walk 2 Direction	To W
N/A	X Walk 1 Width (in)	N/A	N/A	X Walk 2 Width (in)	N/A
	X Walk 1 Slope (%)	0.9		X Walk 2 Slope (%)	5.4

X Walk 1 X Slope (%)	4.7		X Walk 2 X Slope (%)	2.2
N/A	Ramp inside XWalk1?	N/A	N/A	Ramp inside XWalk2?	N/A
	Road Slope (%)	3.4	N/A	Clear Space?	N/A
	Road X Slope (%)	4.8	N/A	Clear Space to XWalk (in)	N/A
N/A	Any Obstructions?	N/A	N/A	Storm Grate/Utility Hazard?	N/A
	Obstruction Type			Storm Grate/Utility Type

Remove & Replace Curb Ramp With Two New Directional Ramps or Equivalent.
