Access Compliance Report Public Rights-of-Way (Curb Ramps)

Intersection ID: 5757 Main Street: FOREST_POND_DR Cross Street: LILY_PAD_CT Location: SE

ADA ID: 9AD2FD0307BD Ramp Type: Perp Initial Pass/Fail: Fail Overall Compliance: No Severity Score: 22.5

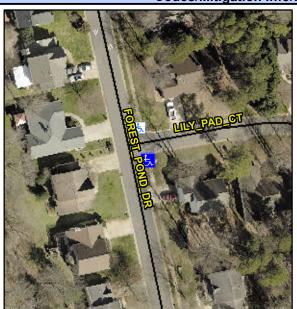
Not Found, R304.5.1, R304.2.2, R304.5.3

Field Measurements/Component Compliance						
Comp	liance Description	Data	Comp	liance Description	Data	
N/A	Ramp Length (in)	51.0	No	Ramp Slope (%)	9.4	
No	Ramp Width (in)	47.0	No	Ramp XSlope (%)	2.9	
N/A	Flare Type LT	N/A	N/A	Flare Type RT	N/A	
N/A	Flare Slope LT (%)	N/A	N/A	Flare Slope RT (%)	N/A	
N/A	Flare Traversable LT?	N/A	N/A	Flare Traversable RT?	N/A	
N/A	Landing Length (in)	N/A	N/A	DWS Provided?	N/A	
N/A	Landing Width (in)	N/A	N/A	DWS Contrast?	N/A	
N/A	Landing Slope (%)	N/A	N/A	DWS Length (in)	N/A	
N/A	Landing X Slope (%)	N/A	N/A	DWS Full Width?	N/A	
N/A	Landing Curb? (Y/N)	N/A	N/A	DWS Offset (in)	N/A	
N/A	Shared Landing?	N/A				
N/A	Gutter Ponding?	N/A	N/A	Gutter Slope (%)	N/A	
N/A	Gutter Lip Ht (in)	N/A	N/A	Gutter X Slope (%)	N/A	
N/A	Painted X Walk1?	No	N/A	Painted X Walk2?	N/A	
	X Walk 1 Direction	To N		X Walk 2 Direction	N/A	
N/A	X Walk 1 Width (in)	N/A	N/A	X Walk 2 Width (in)	N/A	
	X Walk 1 Slope (%)	5.8		X Walk 2 Slope (%)	N/A

Remove & Replace Entire Ramp.
