# Access Compliance Report

## Public Rights-of-Way (Curb Ramps)

| Intersection ID: 31526 | Main Street: WILGROVE WAY DR | Cross Street: CARLEEN WAY DR | Location: | N |
| ADA ID: 9B13DB8E5F10 | Ramp Type: BlendTrans1 | Initial Pass/Fail: Fail | Overall Compliance: No | Severity Score: 8.75 |

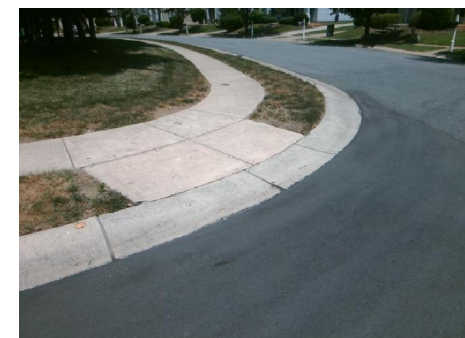
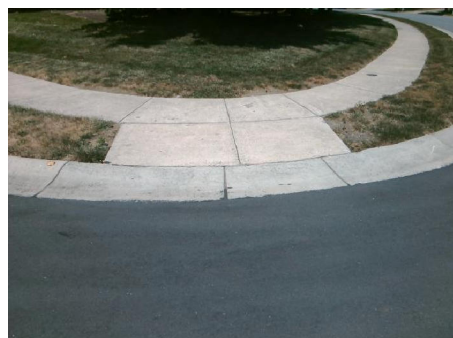
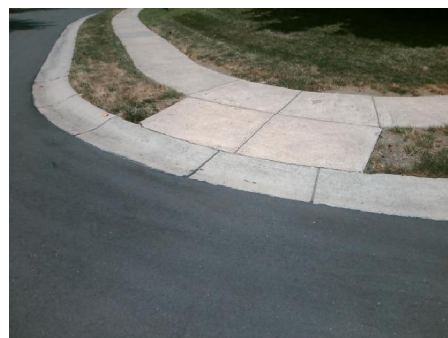
**Not Found, R304.5.1**

| Compliance | Description | Data | Compliance | Description | Data |
|---|---|---|---|---|---|
| No | Ramp Width (in) | 42.5 | Yes | BlendTrans XSlope (%) | 0.4 |
| | | | No | Curb Slope (%) | 14.0 |

**Remove & Replace Curb Ramp With Two New Directional Ramps or Equivalent.**
