# Access Compliance Report

## Public Rights-of-Way

| Intersection ID: N/A | Main Street: GLENBURN_LN | Cross Street: GLENLIVET_CT | Location: NE |
| ADA ID: 9B81CEA29F76 | Ramp Type: PerpDiag | Initial Pass/Fail: Fail | Overall Compliance: No |

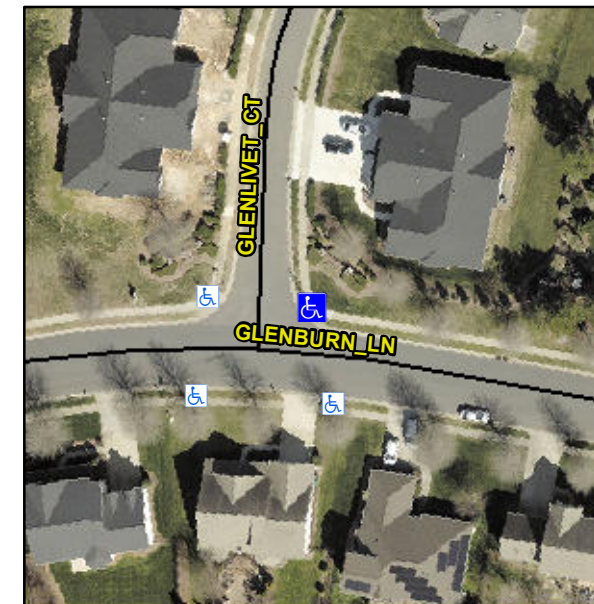
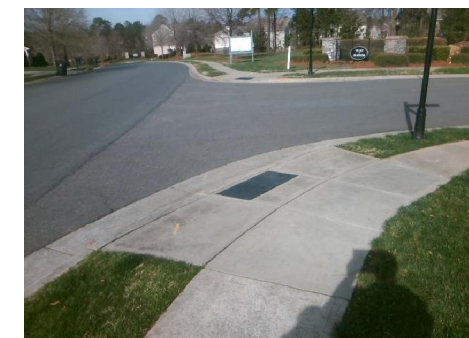
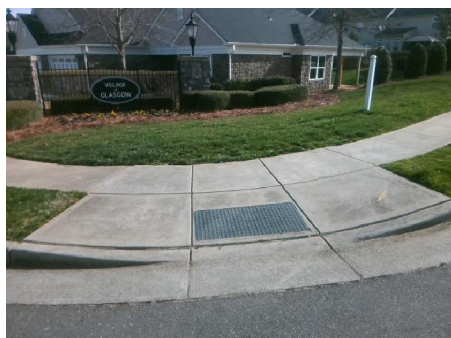
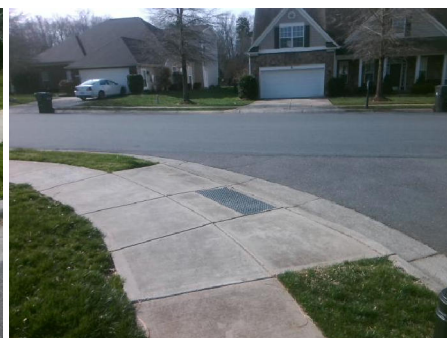
| | | | Severity Score: 33.75 |

**Not Found, R304.5.1, R304.2.2, R304.5.3**

| Compliance | Description | Data | Compliance | Description | Data |
|---|---|---|---|---|---|
| N/A | Ramp Length (in) | 46.5 | No | Ramp Slope (%) | 10.4 |
| No | Ramp Width (in) | 47.0 | No | Ramp XSlope (%) | 5.3 |

**Remove & Replace Curb Ramp With Two New Directional Ramps or Equivalent.**
