Access Compliance Report Public Rights-of-Way (Curb Ramps)

Intersection ID: 19461 Main Street: CHARTER_PL Cross Street: LIDO_AV Location: S

ADA ID: 9C1F133D96DB Ramp Type: PerpDiag Initial Pass/Fail: Fail Overall Compliance: No Severity Score: 12.5

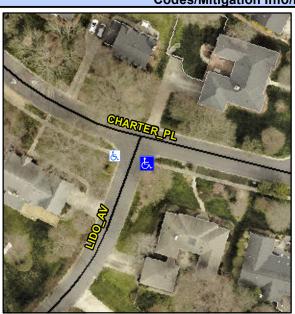
Not Found, R304.2.2

Field Measurements/Component Compliance					
Compliance Description		Data	Comp	liance Description	Data
N/A	Ramp Length (in)	68.0	No	Ramp Slope (%)	9.3
Yes	Ramp Width (in)	48.0	Yes	Ramp XSlope (%)	1.4
N/A	Flare Type LT	N/A	N/A	Flare Type RT	N/A
N/A	Flare Slope LT (%)	N/A	N/A	Flare Slope RT (%)	N/A
N/A	Flare Traversable LT?	N/A	N/A	Flare Traversable RT?	N/A
N/A	Landing Length (in)	N/A	N/A	DWS Provided?	N/A
N/A	Landing Width (in)	N/A	N/A	DWS Contrast?	N/A
N/A	Landing Slope (%)	N/A	N/A	DWS Length (in)	N/A
N/A	Landing X Slope (%)	N/A	N/A	DWS Full Width?	N/A
N/A	Landing Curb? (Y/N)	N/A	N/A	DWS Offset (in)	N/A
N/A	Shared Landing?	N/A			
N/A	Gutter Ponding?	N/A	N/A	Gutter Slope (%)	N/A
N/A	Gutter Lip Ht (in)	N/A	N/A	Gutter X Slope (%)	N/A
N/A	Painted X Walk1?	No	N/A	Painted X Walk2?	No
	X Walk 1 Direction	To NE		X Walk 2 Direction	To NW
N/A	X Walk 1 Width (in)	N/A	N/A	X Walk 2 Width (in)	N/A
	X Walk 1 Slope (%)	5.4		X Walk 2 Slope (%)	0.2

X Walk 1 X Slope (%)	1.2		X Walk 2 X Slope (%)	3.1
N/A	Ramp inside XWalk1?	N/A	N/A	Ramp inside XWalk2?	N/A
	Road Slope (%)	3.2	N/A	Clear Space?	N/A
	Road X Slope (%)	2.9	N/A	Clear Space to XWalk (in)	N/A
N/A	Any Obstructions?	N/A	N/A	Storm Grate/Utility Hazard?	N/A
	Obstruction Type			Storm Grate/Utility Type	
		N/A			N/A
			Yes	Surface Condition? (G/P)	Good

Remove & Replace Curb Ramp With Two New Directional Ramps or Equivalent.
