Access Compliance Report

Public Rights-of-Way

| Intersection ID: 13099 | Main Street: E_TRADE_ST | Cross Street: S_MCDOWELL_ST | Location: W |
| ADA ID: 9C510ED9143F | Ramp Type: Para | Initial Pass/Fail: Fail | Overall Compliance: No |

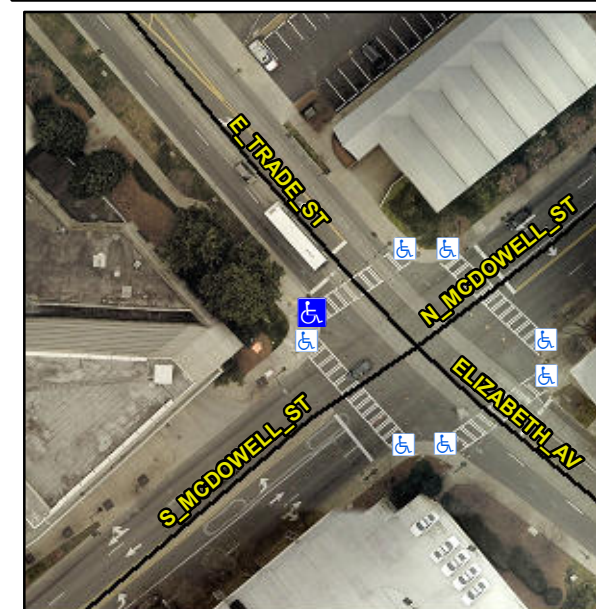
| Severity Score: 25 | | | |

TRAFFIC SIGNAL POLE OBS RT RAMP

R304.3.2

| Compliance | Description | Data | Compliance | Description | Data |
|---|---|---|---|---|---|
| Yes | Ramp Slope LT (%) | 5.5 | No | Ramp Slope RT (%) | 12.9 |

Remove & Replace Entire Ramp.

Total Cost: \$ 1600.00
